SEVEN DEADLY SINS OF LANDSLIDE INVESTIGATION, ANALYSIS, AND DESIGN

Derek H. Cornforth, former president, Cornforth Consultants, Inc., Portland, Oregon

Abstract: In practicing as a geotechnical consultant for more than 45 years, the author has observed that certain types of error recur in landslide studies and design. These errors, quite apart from their technical ramifications, frequently lead to costly lawsuits and sometimes fatalities.

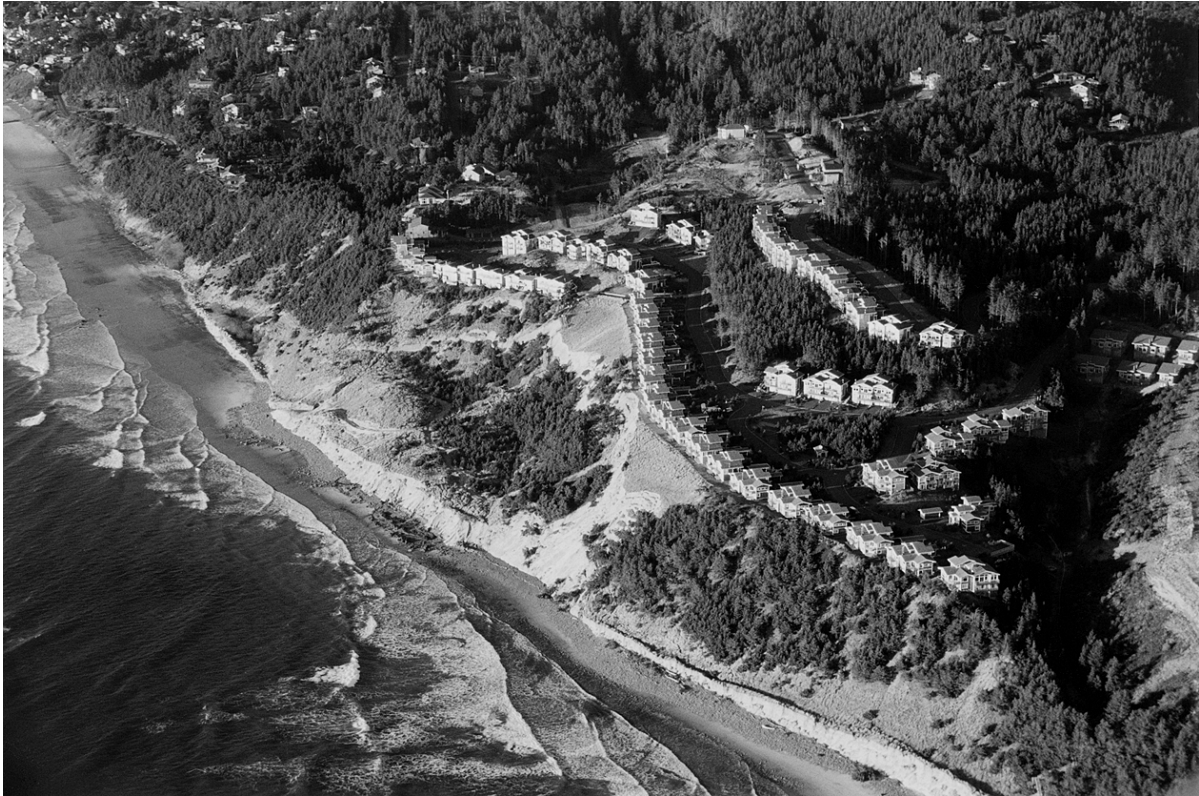
Figure 1. The Capes landslide. General view of slide adjoining the Pacific Ocean.

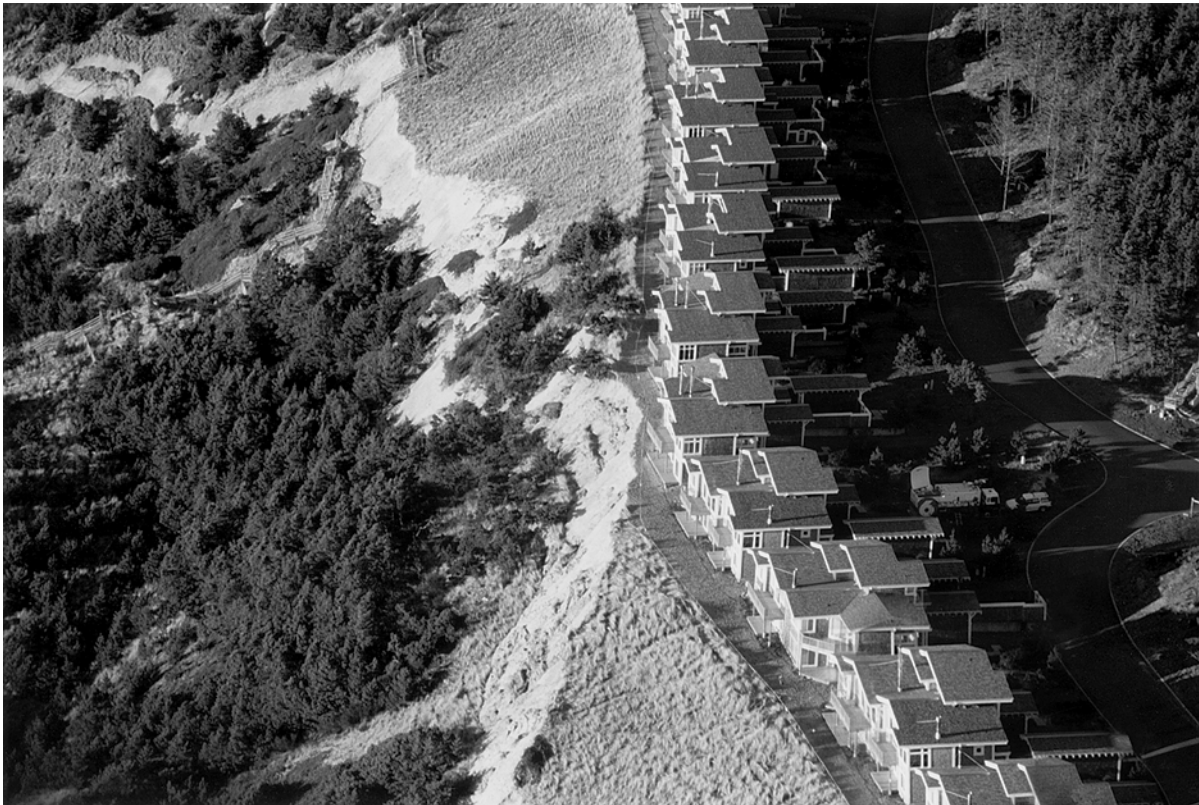
Figure 2. The Capes landslide. Headscarp close to houses on bluff.

In February, 1998, the ground below the cliff abruptly moved towards the sea creating a landslide headscarp that, in one part of the site, extended to the top of the slope and threatened the safety of several houses (Figure 2). The cause of the landslide was severe erosion of the sandy beach by a winter storm.

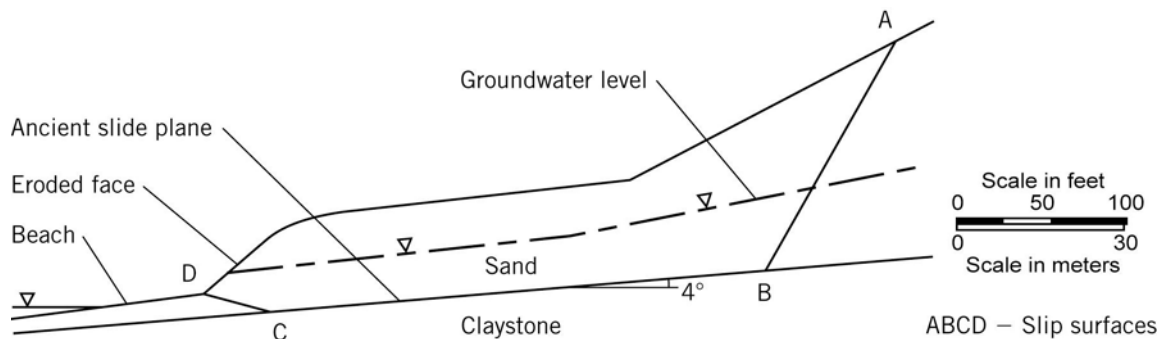
The author was retained by one party to this lawsuit, but did not participate in the ground investigations that occurred after the failure. Based on available information, a triple wedge landslide model ABCD is appropriate (Figure 3). The main slippage occurred near the contact between the dense sand and an underlying stratum of very stiff clay that was a pre-existing slip plane.

Figure 3. The Capes landslide. Geological cross-section.

This site had been examined by a geotechnical firm before development, but the pre-existing landslide condition at the base of the cliff was missed. An experienced engineering geologist could have recognized the landslide condition from the landform. Although the houses were placed on stable ground at the top of the slope, it is clear from Figure 2 that they were too close to the cliff edge and thus vulnerable to regressive movement of the ground should the pre-existing landslide reactivate.

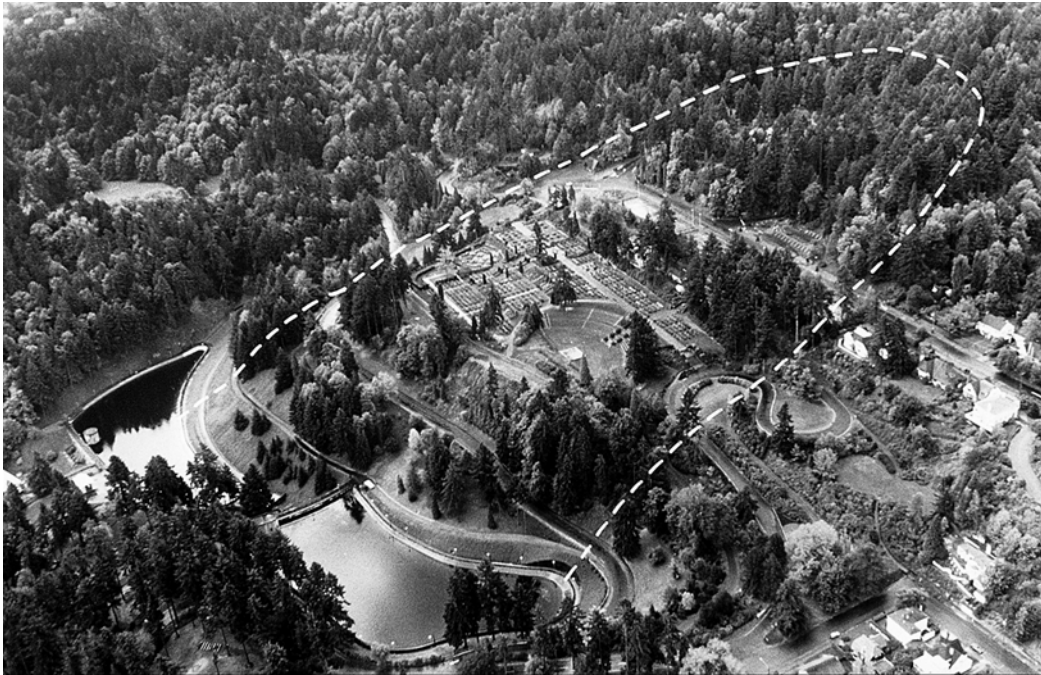
Figure 4. Washington Park Reservoirs landslide. The two reservoirs are at lower left. Perimeter of slide shown by broken white line.

The Washington Park landslide is an example of ancient landslide terrain reactivation. The excavation for the reservoirs was about 3% of the landslide mass. In a major lawsuit that followed construction, the city was exonerated from liability for residential damages because the judge could not accept that such a minor excavation, relative to the entire landslide mass, could be responsible for the large observed movements. However, in current knowledge, there have been many examples similar to this one showing that minor adverse changes in slope stability can produce disproportionately large movements in pre-existing landslides that are marginally stable prior to the changes.

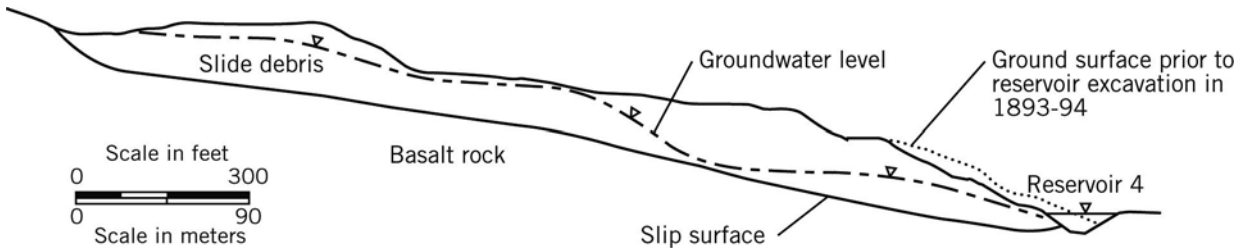
During the site investigations, 22 deep shafts and 9 borings showed that the slip surface was 56 to 111 feet (17 to 34 m) below ground (Figure 6), generally occurring within a seam of highly plastic clay. The landslide debris was a heterogeneous mixture of stiff clay and broken rock. The landslide was stabilized by first using pumps to drawdown the water table, followed by digging tunnels along the slip surface to provide a network of interconnecting gravity drains. Today, the landslide creeps downhill at only a fraction of an inch per year.

Figure 6. Washington Park Reservoirs landslide: Geological section X-X

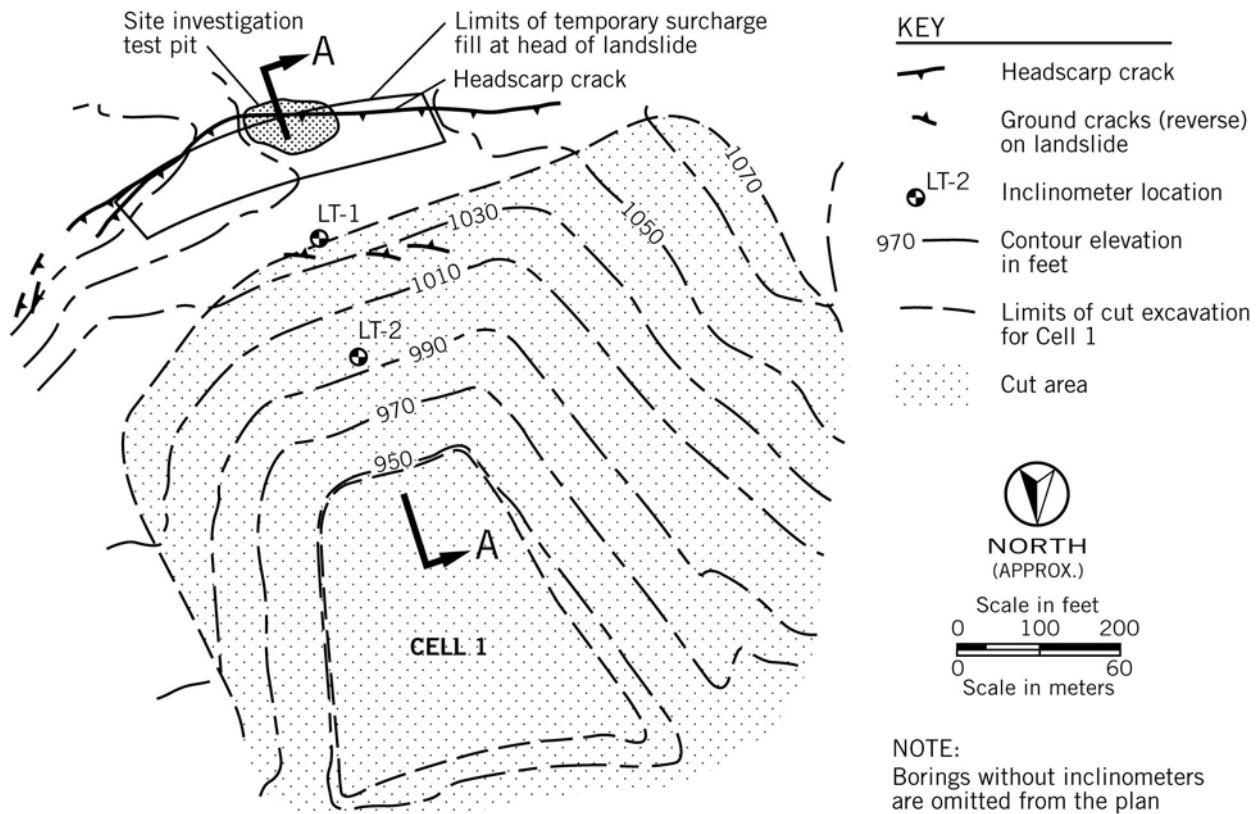
Cell 1 of this landfill expansion was excavated in 1993 with side slopes of 3:1 (horizontal:vertical), and involved removal of 325,000 cu.yds. (250,000 cu.m) of dense silt (Figure 10). In December, 1993, shortly after the excavation had been completed, a crack 700 feet (210 m) long was observed 100 to 200 feet (30 to 60 m) behind the top of the deep cut slope at the south end of the cell. The project consultants dug a 30-foot (9 m) deep test pit near the mid-length of the crack and concluded that the slip surface was at a depth of about 20 feet (6 m) below the ground surface.

Figure 10. Northern Wasco County landfill landslide. Site plan, Cell 1

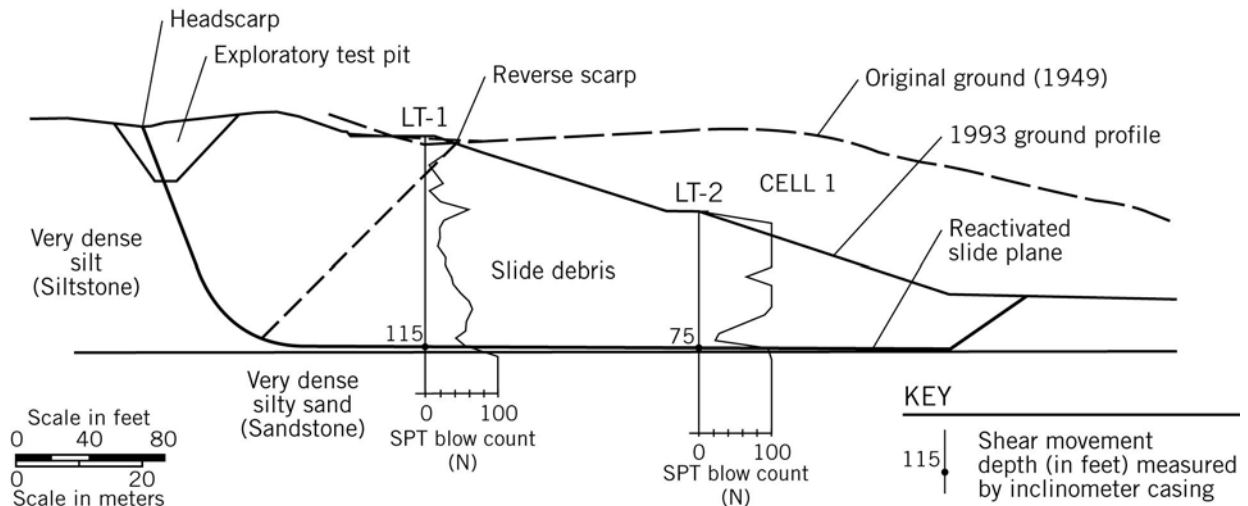
Figure 11. Northern Wasco County Landfill landslide. Section A-A

The landslide was modeled as a triple-wedge failure with slippage occurring along a near-horizontal ancient slip surface. Geological studies confirmed that the site was an ancient landslide.

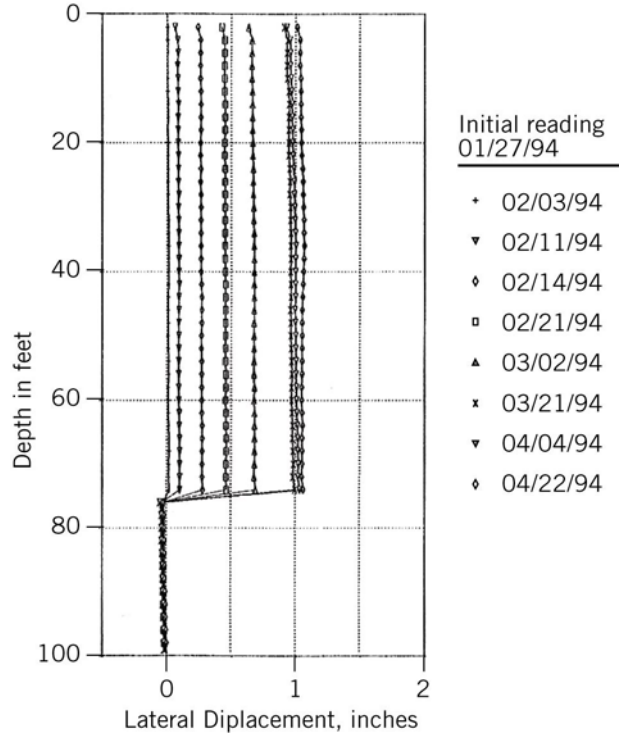
The result for inclinometer LT-2 was movement at a depth of 74 to 76 feet (22 to 23 m), as shown on Figure 12, and movement at 114 to 118 feet (35 to 36 m) in LT-1 (not illustrated). Clearly, the estimated depth of the slip surface in the test pit was a large error and could have resulted in serious design repercussions if it had been accepted as correct.

Figure 12. Northern Wasco County Landfill landslide. Inclinometer LT-2

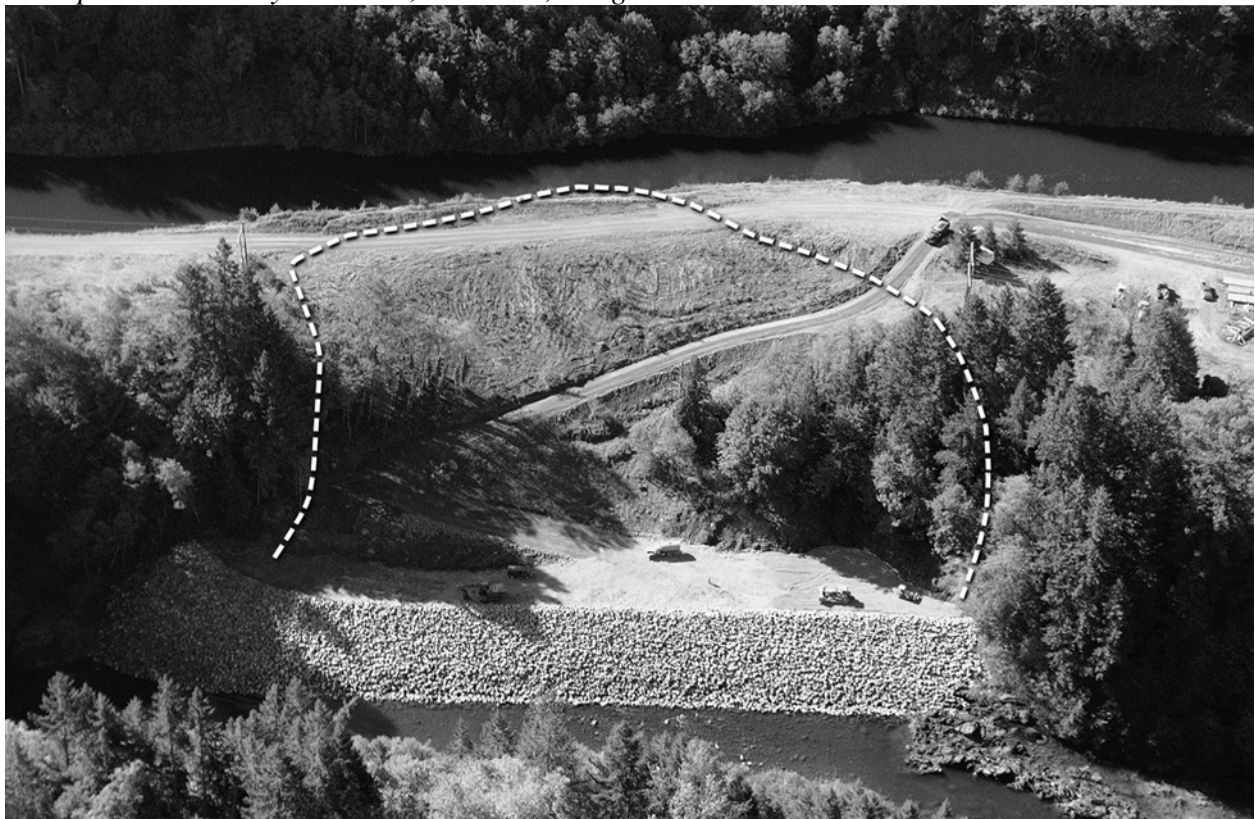
Figure 13. Faraday Canal landslide. Faraday Canal at top. Clackamas River at bottom (with remedial buttress in place). Perimeter of landslide shown by broken white line.

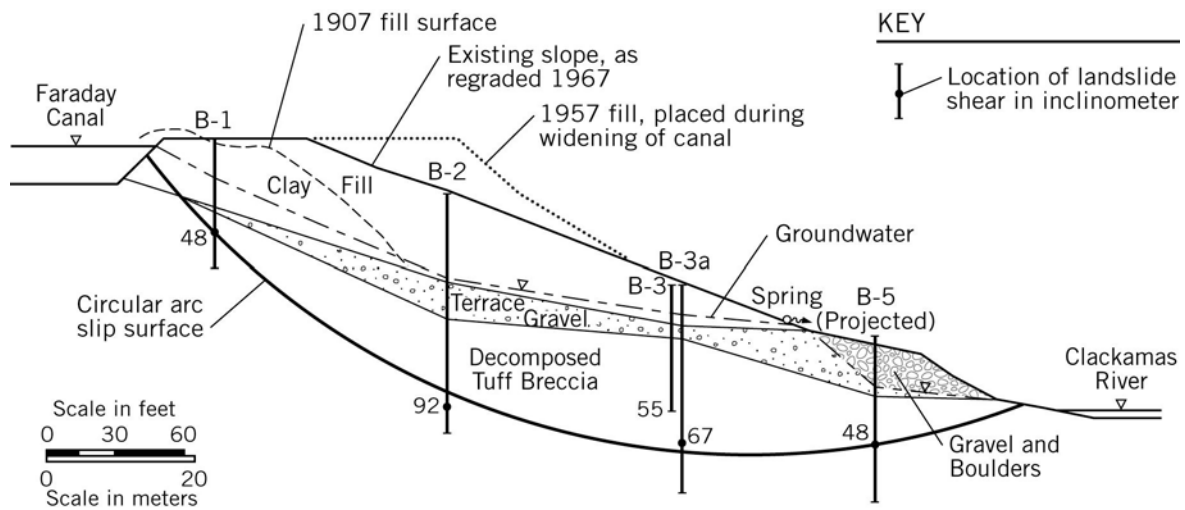
Figure 14. Faraday Canal landslide. Geological section through center of slide

All the borings were instrumented with inclinometers. The observed movements (Figure 14) are a good example of a deep-seated circular arc slope failure. The slip surface passes almost entirely through the hard clay stratum below the fill and terrace gravel.

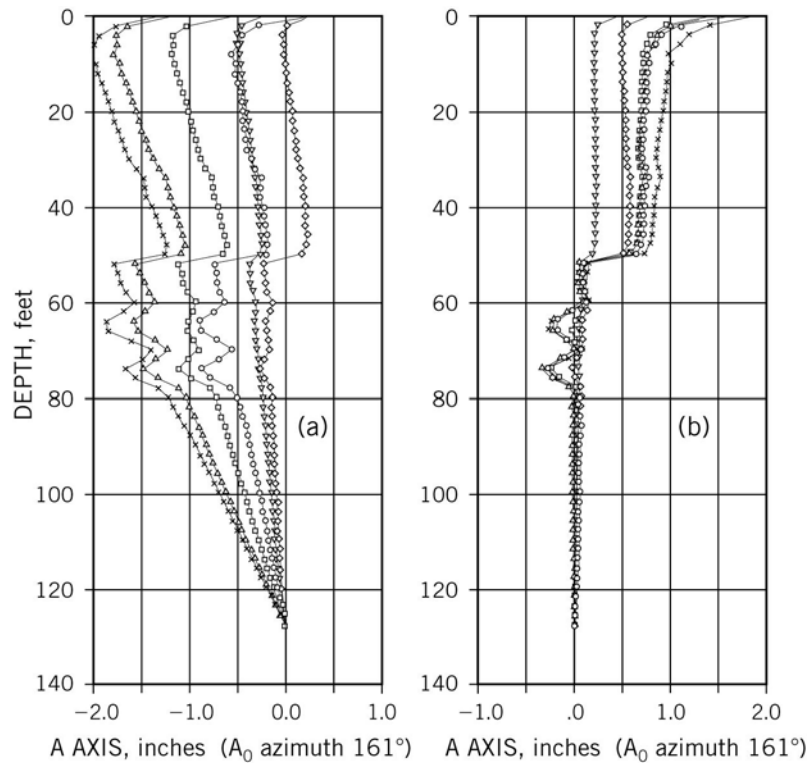
Figure 16. “Windshield wiper” effect for inclinometer readings, Percy Slide, Oregon:
(a) date uncorrected (b) data corrected for bias shift error

When corrected, as shown on Figure 16(b), the data shows that the actual landslide shear movement is occurring from 50 to 52 feet (15.2 to 15.9 m) below the surface.

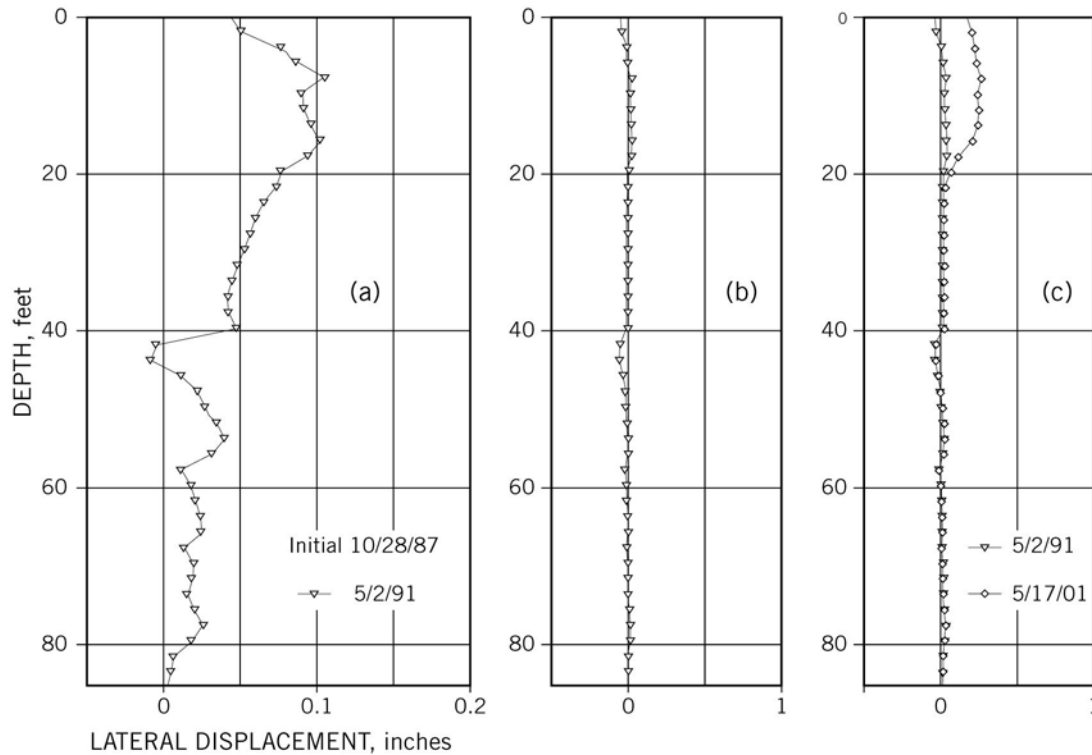
An example of an exaggerated scale is shown on Figure 17(a). Such graphs can cause bizarre speculations of what is occurring within the landslide. In reality, the various wiggles in the graph are due to limitations of the inclinometer *system*, as mentioned earlier. When corrected for bias shift error and plotted to a more normal scale, as shown for this example on Figure 17(b), there is no movement occurring. Later, small movements occurred at this landslide site between 15 and 21 feet (4.6 and 6.4 m) below the ground surface (Figure 17c).

Figure 17. Effect of using highly exaggerated scales:

The author recommends that at least 0.15 inch (4 mm) of simple shear displacement should be observed at the discrete shear zone to confirm the depth of slippage. Also, displacements above the shear zone should be downslope of those below the shear zone.

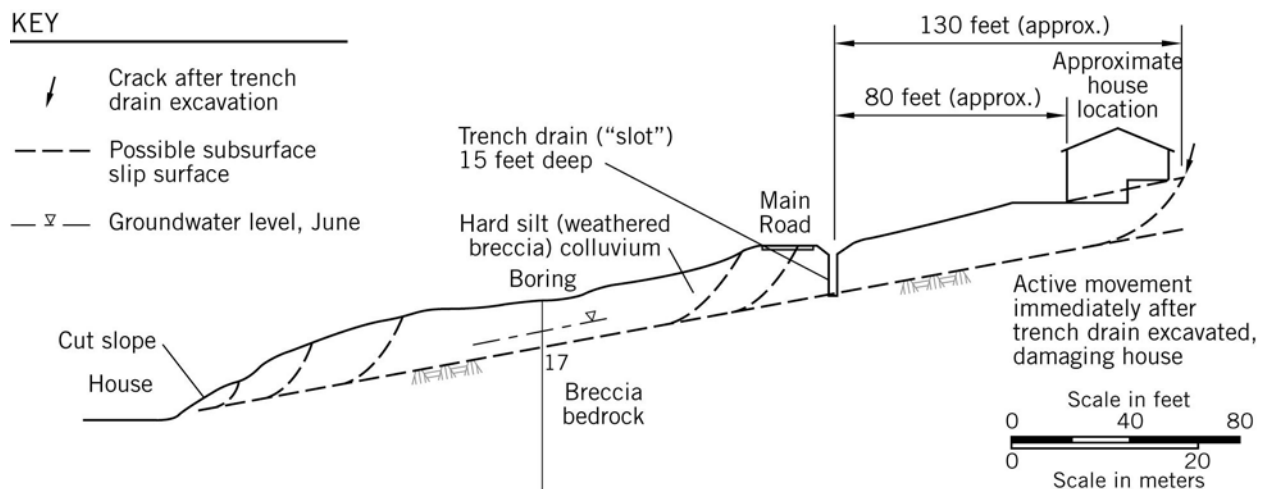
A relatively minor excavation at the base of a hillside caused cracks to develop in the slope between the excavation and the road above (Figure 18). Borings put down alongside the road showed that hard bedrock (breccia) was 12 to 15 feet (4 to 5 m) below the existing ditch. A geotechnical consultant recommended that a 450-foot (137 m) long interceptor drain be constructed along the ditchline to intercept groundwater before it reached the unstable area below. The overburden soil was hard silt mixed with rock fragments (colluvium).

Figure 18. Kalama landslide: trench drain excavation causing movements in the upper slope.

In late spring, the contractor started trenching across the ancient landslide (colluvium) using a trench box to protect the workers from cave-ins. Almost immediately, there were reports that the uphill wall of the open trench was periodically collapsing. A house (Figure 18) uphill from the trench experienced severe cracking. This house was 130 feet (40 m) away from the trench, and there was anecdotal evidence that cracks were seen several hundred feet further upslope.

In this example, the consultant did not recognize the ancient landslide condition (see Sin No. 1 earlier) at the site, and the specifications did not require that closely-sequenced construction procedures would be needed to support the hillside during the trench construction. Instead, the contractor simply dug the trench leaving substantial lengths of it open for many days. This “slot” reactivated the ancient landslide terrain above it, and thus duplicated the cause of the original failure in the slope below.

The interceptor drain was finally installed using closely-sequenced construction procedures (see below). However, there was a substantial claim for damages from the affected homeowner due to the error of allowing an open trench to be cut across a pre-existing landslide.

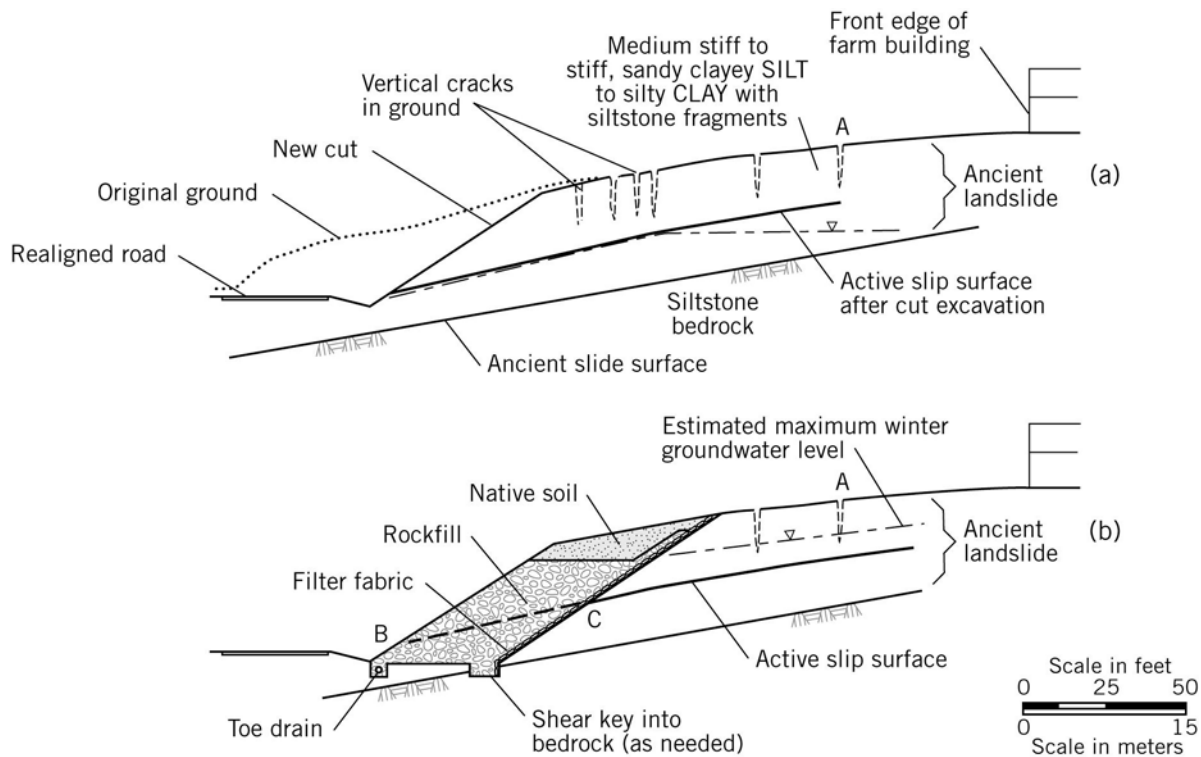
A highway improvement project near Lorane, Oregon, required a cut of 47 feet (14 m) horizontally into the hillside (Figure 19a), which was within ancient landslide terrain. Although the cut was made during the drier summer months, numerous vertical cracks developed over a distance of 90 feet (27 m) behind the top of the cut slope.

Figure 19. Lorane Road landslide: (a) landslide section (b) remedial section

At this site, the pre-existing landslide condition was not recognized prior to construction of the cut. Excavating into the slope removed support from the marginally stable slope, thereby reactivating the ancient landslide. This example demonstrates the use of closely-sequenced construction to provide support when a “slot” or downhill removal of support is cut into a landslide condition.

To prevent further regression towards a building upslope, a replacement buttress was designed. To build a replacement buttress, the weak soils at the outer face of the landslide are replaced by a stronger fill; in this example, shot rockfill was selected for the repair (Figure 19b).

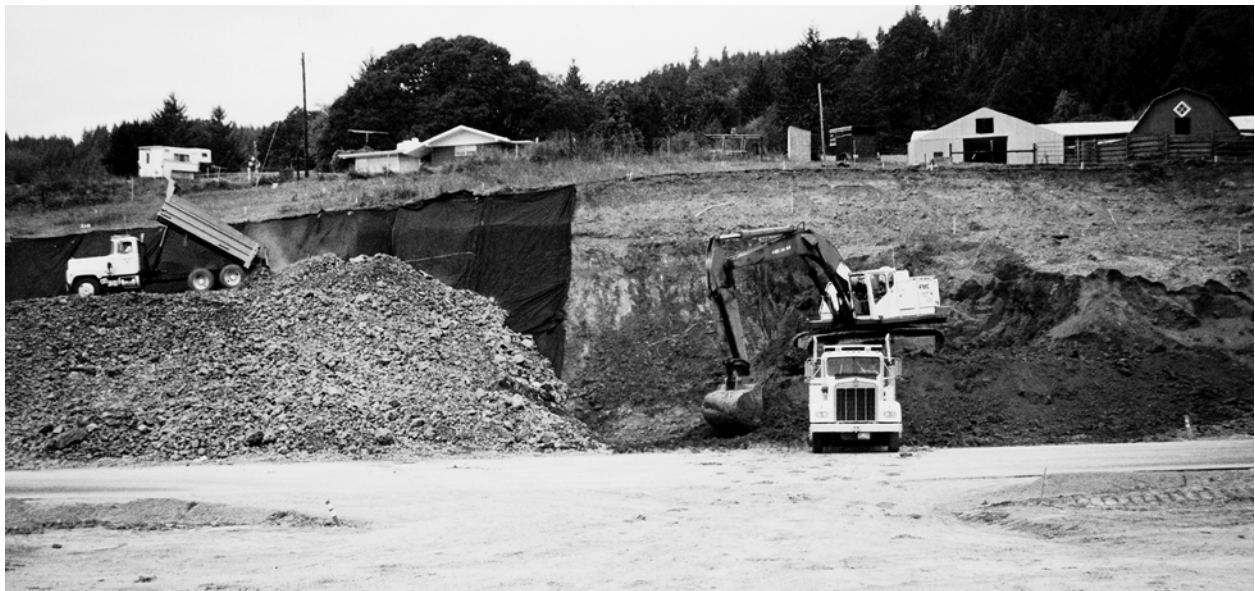
Figure 21. Closely-sequenced construction method being applied at Lorane Road landslide. On right, a backhoe excavates soil and loads spoil into a dump truck. On left, rockfill is being dumped and spread to build a buttress. Filter fabric (dark gray) is laid on the cut slope behind the rockfill.

Two stages of excavation were needed at the Lorane Road site. The first stage was to excavate the upper part of the slope, above the water table, by customary open excavation methods. For the second stage, a closely-sequenced construction procedure was followed, restricting the maximum width between the bases of the excavated soils and the rockfill (distance x , Figure 20) to 20 feet (6 m). A photograph of the work at Lorane Road is shown on Figure 21.

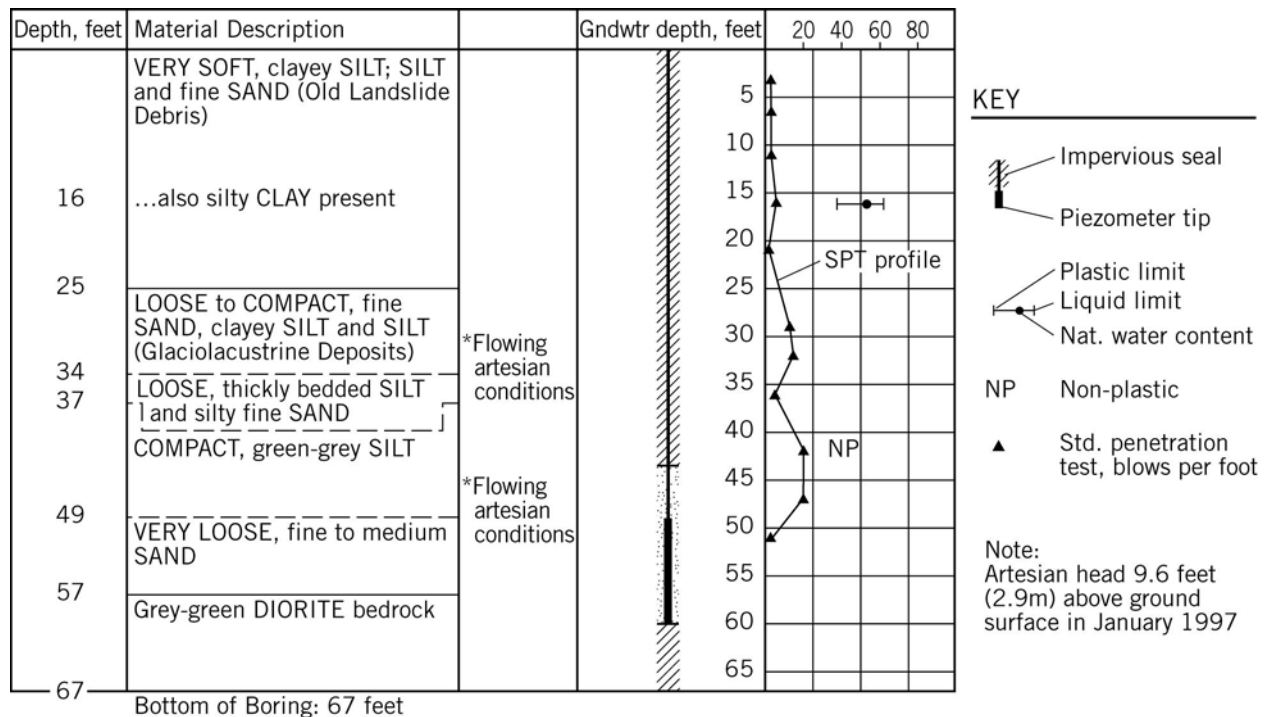
The site investigation for the project encountered a flowing artesian condition in boring A-3 on the north (uphill) side of the excavation area (Figure 23). The boring log, simplified from the original, is shown on Figure 24. The artesian head, at a depth of 31 feet (9.5m) in the boring, was 9.6 feet (2.9m) above the ground surface in January, 1997.

Figure 24. Bonners Ferry landslide. Summary log for boring A-3

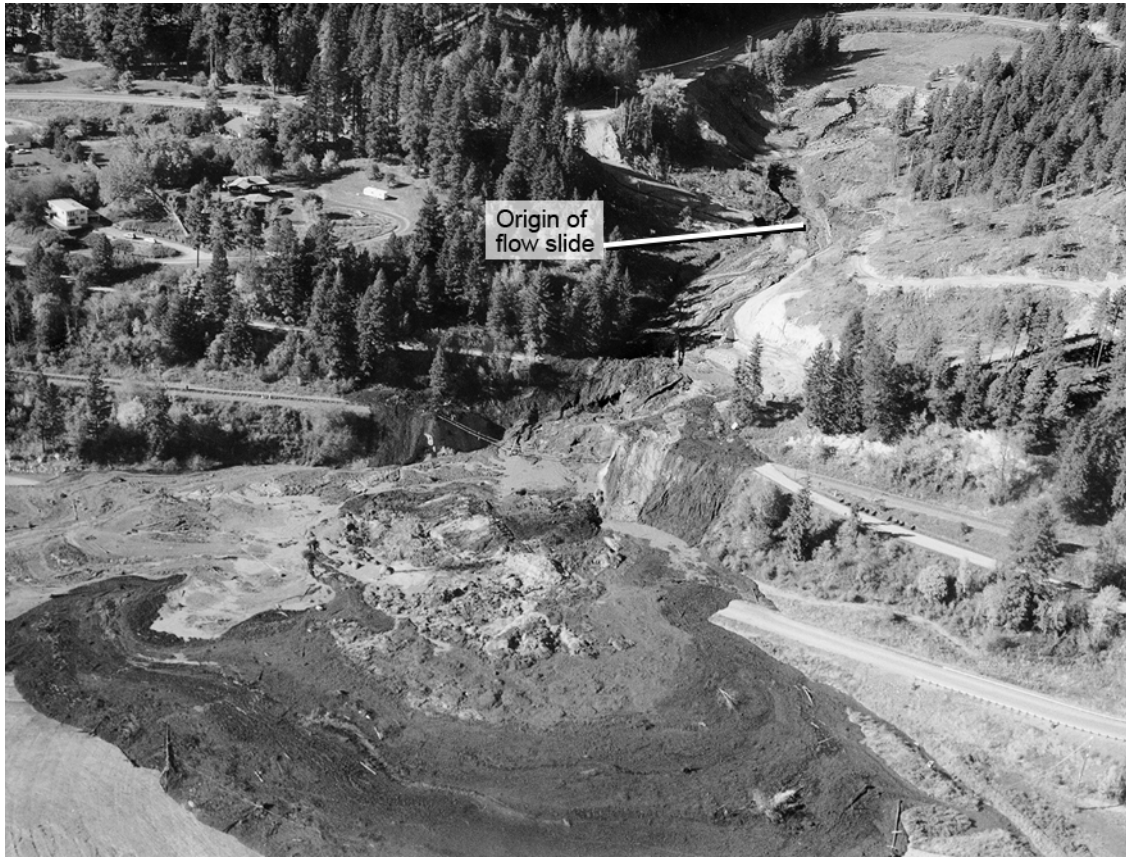
On October 16, another small flow slide occurred at about 3 p.m., and this was followed by a major mudflow at 5:30 p.m. Numerous flow pulses continued from this time until about 3 p.m. of the next day (i.e. more than 20 hours). These flows built up behind the high railroad embankment downslope and then broke through the embankment onto the flood plain below (Figure 25). A video was taken of the flowing soils, estimated to be 10 feet (3 m) deep, coming down the ravine. When the movements stopped, the former cut face had regressed into a large headscarp that was 700 feet (210 m) further upslope. It eroded part of Highway 95, which was still in use. However, there were no fatalities or injuries.

Figure 25. Bonners Ferry landslide. Aftermath of the major flow slide, showing rupture through the railroad embankment and into the flood plain (in foreground). (Photo: David Kramer)

It is likely that the depth of cut left only a relatively thin layer of in-place sediments above the artesian stratum, causing a critical hydraulic gradient. The upwelling of artesian groundwater liquefied the soils to begin the flow slide. Once initiated, it progressed steadily upslope as ground was lost and flowed away, undermining the ground above to continue the flow.

There were severe economic losses. The main line of the railroad was closed for several days until the embankment could be rebuilt. Highway 95 was closed for 18 days, and required construction of an alignment shift into the hillside where it had been undermined by the flow slides. The road closure required a 112-mile (180 km) detour. Power to the town of Bonners Ferry was lost and schools were closed for several days. The construction contract was delayed, and there were lawsuits to recover damages.

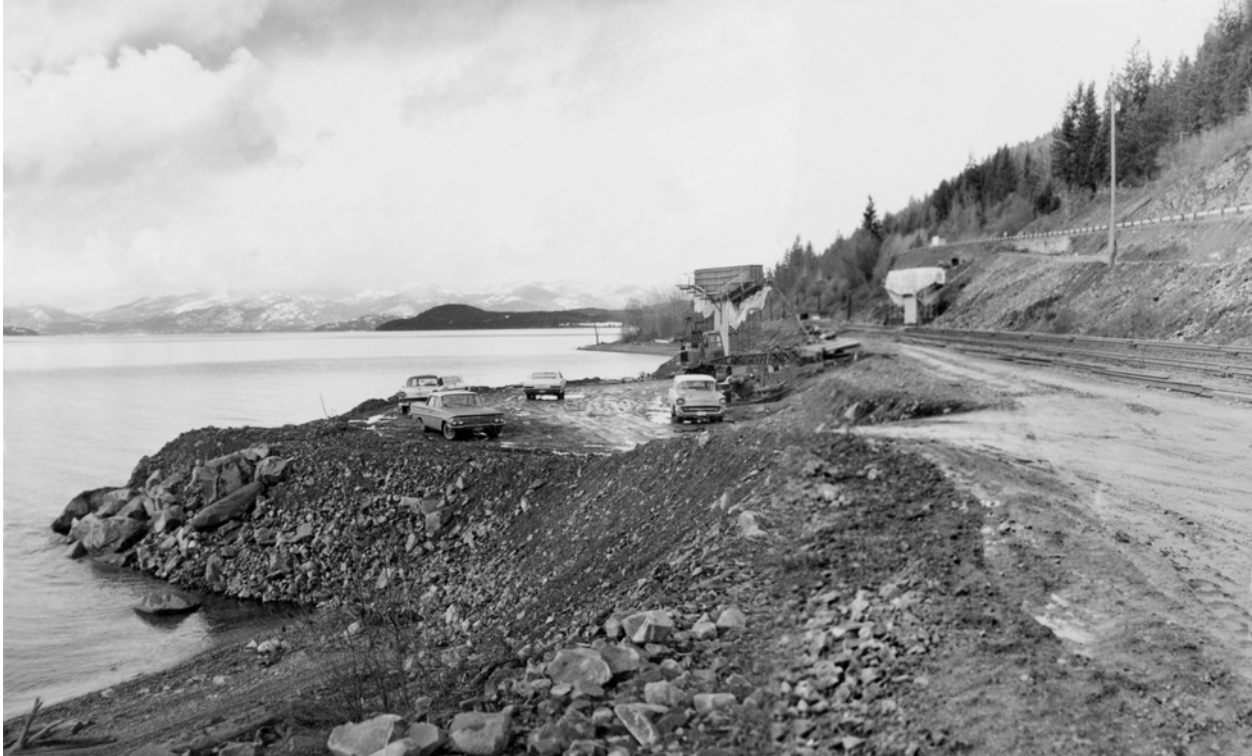
Figure 26. Lake Pend Oreille landslide. Hope Overpass site. Piers 2 and 3, on opposite sides of the Northern Pacific railroad tracks, are under construction in the background.

The embankment fill was a shot rock, primarily of gravel size. This was end-dumped and pushed into the lake. However, the fill simply “disappeared” into the lake as quickly as it was being placed. According to an eye-witness report, sliding was continuous and dump truck operators refused to drive their trucks near the fill edge. Work was suspended after an estimated 30,000 cu.yds.(9,100 cu.m) of fill had slid into the water.

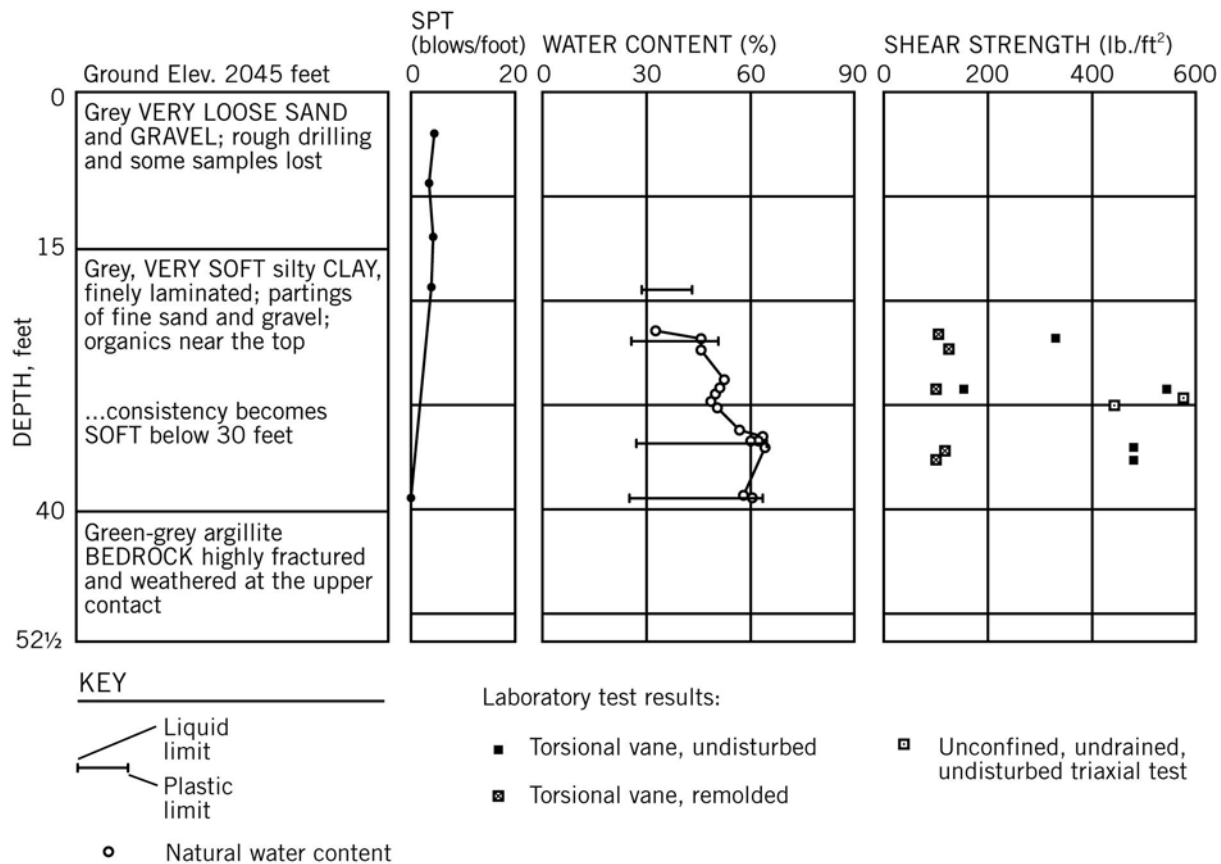
Boring B-6 is typical of the near shore conditions (Figure 29). This boring had gravelly soils near the ground surface, the gravels being either beach gravel and/or fill from the construction work (there was poor sample recovery in this stratum). For all borings, the lacustrine clay

Figure 29. Boring log and clay properties in boring B-6

sediments were described as very soft clayey silt to silty clay containing thin layers and partings of sandy silt, fine sand, and occasionally gravel. Many samples had a laminated (varved) structure. The average index properties were: liquid limit 54; plastic limit 27; natural water content 68%. The shear strengths, based on torvane tests, increased approximately linearly from only 50 lbs./sq. ft. near the surface to 250 to 600 lbs./sq. ft. at a depth of 30 feet (metric: 2.4 kPa near surface to 12 to 29 kPa at 9m depth). The median value of sensitivity to remolding is 5. The measured effective stress parameters in consolidated-drained triaxial tests using very slow rates of strain were: $c' = 0$, $\phi' = 24$ degrees.

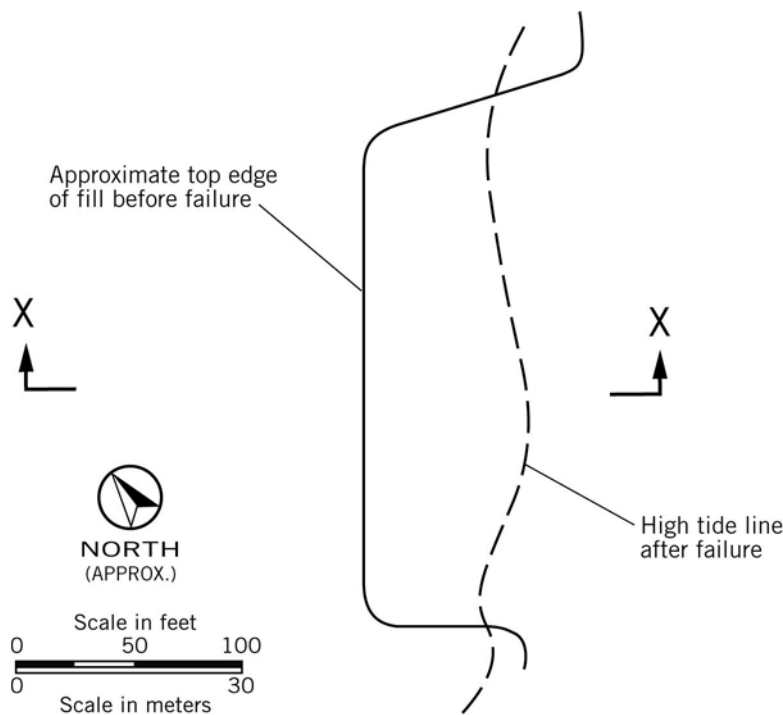
The approximate plan of the fill (Figure 32) shows that the level top surface was about 230 feet (70 m) long parallel to the shoreline and extended 50 to 70 feet (15 to 21 m) into the bay. A “before” and “after” cross-section X-X near the center of the fill (Figure 33) shows the loss of ground. It is calculated that about 13,000 cu.yds. (10,000 cu.m) of fill was lost.

Figure 32. Skagway October 1966 flow slide: Site plan

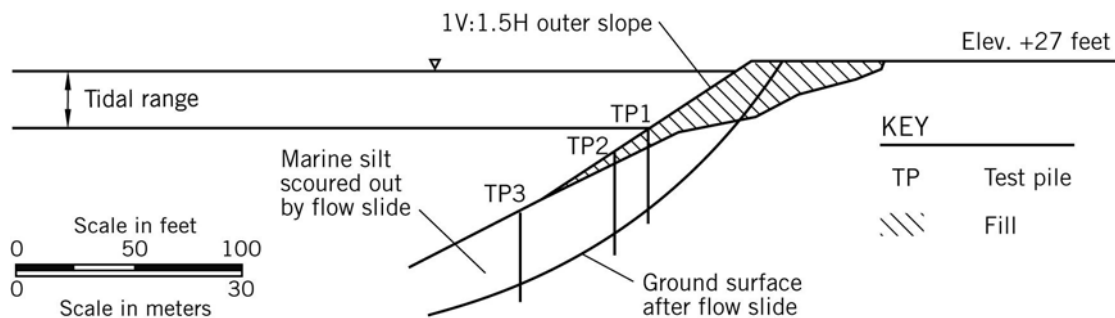
Figure 33. Skagway October 1966 flow slide: Section X-X
