VINGTIEME CONGRES
DES GRANDS BARRAGES
Beijing, 2000

**AN INTEGRATED STRATEGY FOR SEEPAGE CONTROL FROM BULL RUN
DAM # 2 SPILLWAY APPROACH CANAL (*)**

Azad MOHAMMADI, Ph.D., P.E.
City of Portland Bureau of Water Works

Andy VESSELY, P.E., C.E.G.
Cornforth Consultants, Inc.

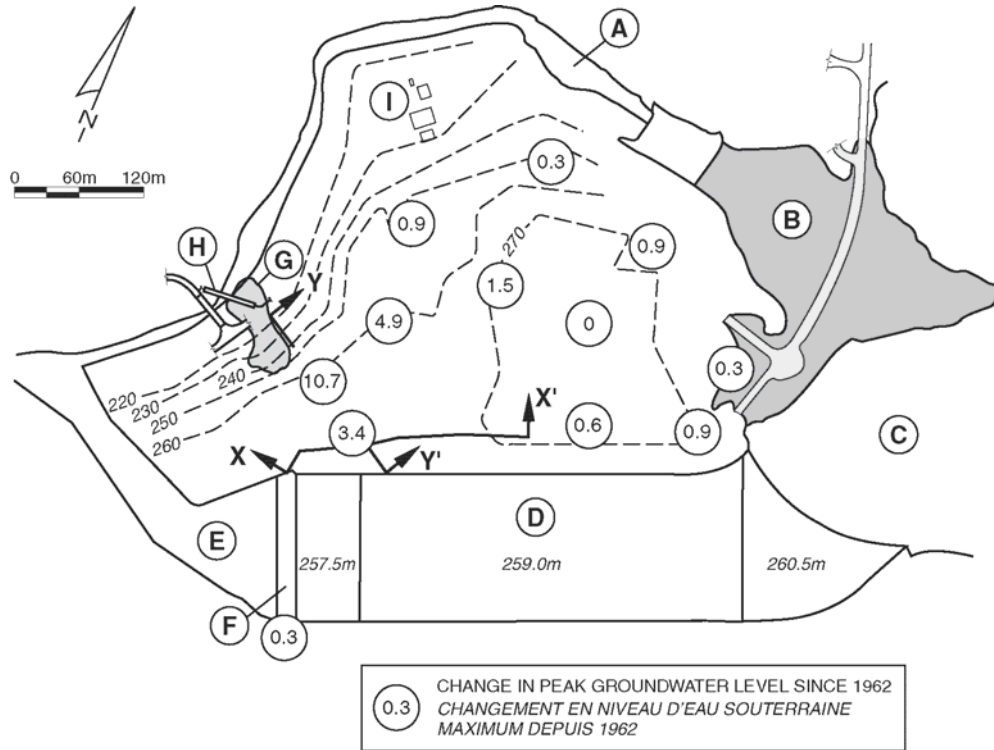
Fig. 2

Of the 25 original piezometers, 12 are located in the central area or near the spillway. These piezometers are P-13, P-14, P-15, P-16, P-17, P-18, P-19, P-20, P-22, P-23, P-25, and P-32/35 (Fig. 1). Additional piezometers were installed in the 1990s to provide more information on groundwater levels north of the spillway. These recent piezometers are P-46 through P-52, and P-101 through P-109. Piezometers P-101 to P-109 were installed in 1998-99. Due to the short historical time span, these piezometers were not included in our review of historical piezometer data.

Yearly plots of groundwater levels for each piezometer from 1964 to 1998 were reviewed, and the maximum and minimum levels were recorded for each piezometer. The decade summary is tabulated in Table 1. Based on recommendations from the Federal Emergency Regulatory Commission (FERC) and independent consultants, about half the piezometers from 1976 through 1990 were not read. Plotted at each piezometer on Figure 2 is the change in peak groundwater level from the 1960s to the 1990s. Only three piezometers (P-22, P-23, and P-32/35) show a groundwater increase greater than 1.5 meters (5 feet). These three piezometers, located north of the spillway, show a moderate to strong correlation with the canal/reservoir level. Peak groundwater levels have risen in these piezometers 4.9, 3.4, and 10.7 meters, respectively (16, 11 and 35

feet), since initial reservoir filling and operation of the spillway. The remainder of the piezometers in the central area has not shown a significant increase in groundwater levels since 1964. Piezometers P-16, P-17 and P-19, located along the north side of the canal closer to the reservoir, have shown only minor increases of 0.3 to 0.9 meters (1 to 3 feet) over the 35 year-period. Similarly, P-25 on the south side of the spillway has shown virtually no change in groundwater level.

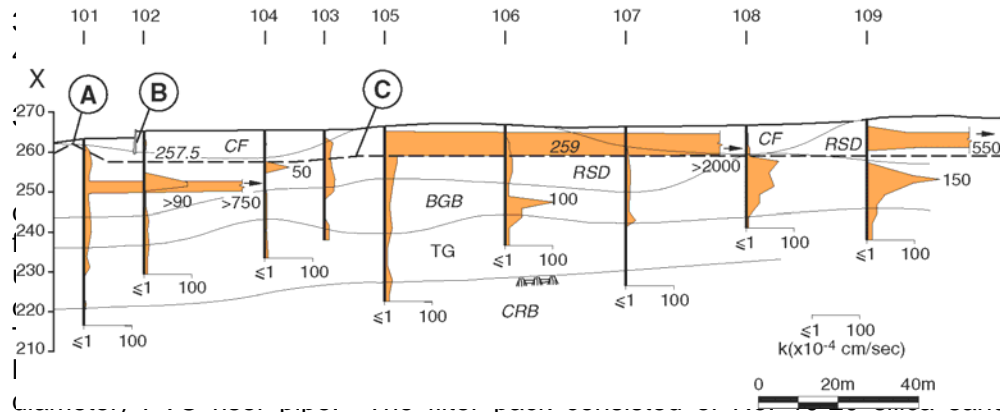
Fig. 3

Landslide debris was encountered in all of the borings except for P-108. The slide debris consists predominantly of nested blocks and boulders of very soft (R1) to soft (R2), decomposed to highly weathered volcanic breccia (Rhododendron Formation). The matrix between the nested Rhododendron blocks consists of medium dense, slightly clayey, gravelly, silty sand. The majority of the slide material originated from the bluffs above the right abutment of the dam. The thickness of the landslide debris ranges from 8.2 meters (P-104) to 18.5 meters (P-101) (27 feet to 61 feet). The slide debris apparently pinched-out in the area of P-108 during emplacement, or was subsequently eroded.

The alluvial deposits beneath the slide debris had lower permeabilities than the slide debris, ranging between 0.15×10^{-4} cm/sec. to 150×10^{-4} cm/sec. Permeabilities for the cemented terrace deposits were even lower, ranging from 0.09×10^{-4} cm/sec. to 20×10^{-4} cm/sec. Likewise, the permeabilities for the basalt were low, ranging from 0.02×10^{-4} cm/sec. to 10×10^{-4} cm/sec. The permeability results are plotted graphically on cross-section X-X' (Fig. 3).

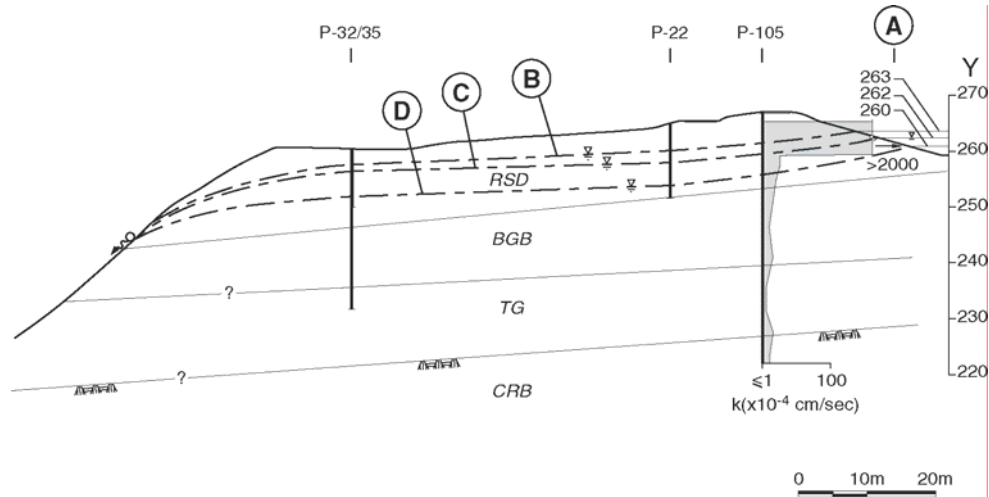
Fig. 4

indicate that the landslide debris north of the canal consists of nested blocks of volcanic breccia within a matrix of silty, gravelly sand. Over time, piping erosion can occur when water seeping from the canal under a high gradient carries the finer fraction of the slide matrix into larger voids within the nested breccia blocks.

Cross-section Y-Y' (Fig. 4) shows how P-22 and P-32/35 respond to varying canal water levels. During winter storms, the water level in the canal can reach elevation 263 meters (864 feet) or higher; water levels in P-22 spike 1.8 meters (6 feet) above normal levels, and P-32/35 spikes 1.2 meters (4 feet). Conversely, when the canal is lowered 1.5 meters (5 feet) from normal pool to elevation 260.5 meters (855 feet) in the summer, a significant groundwater drop of 3.0 to 4.3 meters (10 to 14 feet) occurs in P-22 and P-32/35. It appears that the response of the piezometers is the result of one or more high permeability zones in the canal near boring P-105. One such zone was encountered in P-105 from 1.5 to 7.6 meters (5 to 25 feet). Groundwater has been measured at the base of this zone when the canal is at elevation 262 meters (860 feet), the normal reservoir pool level. One explanation for the piezometer response is that the highly permeable zone in P-105 acts like an underground weir. As water in the canal rises above 262 meters (860 feet) during storms, groundwater rises into the high permeability zone and causes the observed spikes in P-22 and P-32/35. Similarly, when the canal is lowered in the summer, groundwater in the area of P-105 drops below the high permeability zone and effectively cuts off the flow of water towards P-22 and P-32/35, resulting in the significant drops in these piezometer water levels.

The leakage appears to be coming from the side of the canal, not the floor. A review of the canal levels during summer drawdown indicates that the canal
