# ANALYSIS & MITIGATION OF A LANDSLIDE IN DISCONTINUOUS PERMAFROST

**Abstract:** The geotechnical investigation and stabilization design for a landslide located near Fairbanks, Alaska, revealed several issues with testing and modelling landslide shear zones in permafrost materials. The subsurface soils consist of frozen silts with zones of organics and ice inclusions (wedges and lenses), and underlain by zones of unfrozen sand and gravel. A 30 m deep mining pit was excavated downslope of a highway, effectively removing lateral support and causing instability. Borings were drilled and instrumented with inclinometers, standpipe observation wells, vibrating-wire piezometers and thermistors. Measured ground movements indicated that the shear zone passed through both frozen and unfrozen soils. The literature was researched to check for documentation of residual shear strengths on frozen silts; however, there is very little information published on this subject. Attempts to back-calculate the effective residual friction angles were complicated since the actual groundwater pressure distribution along the shear zone could not be reliably estimated. Ultimately, the design of stabilization

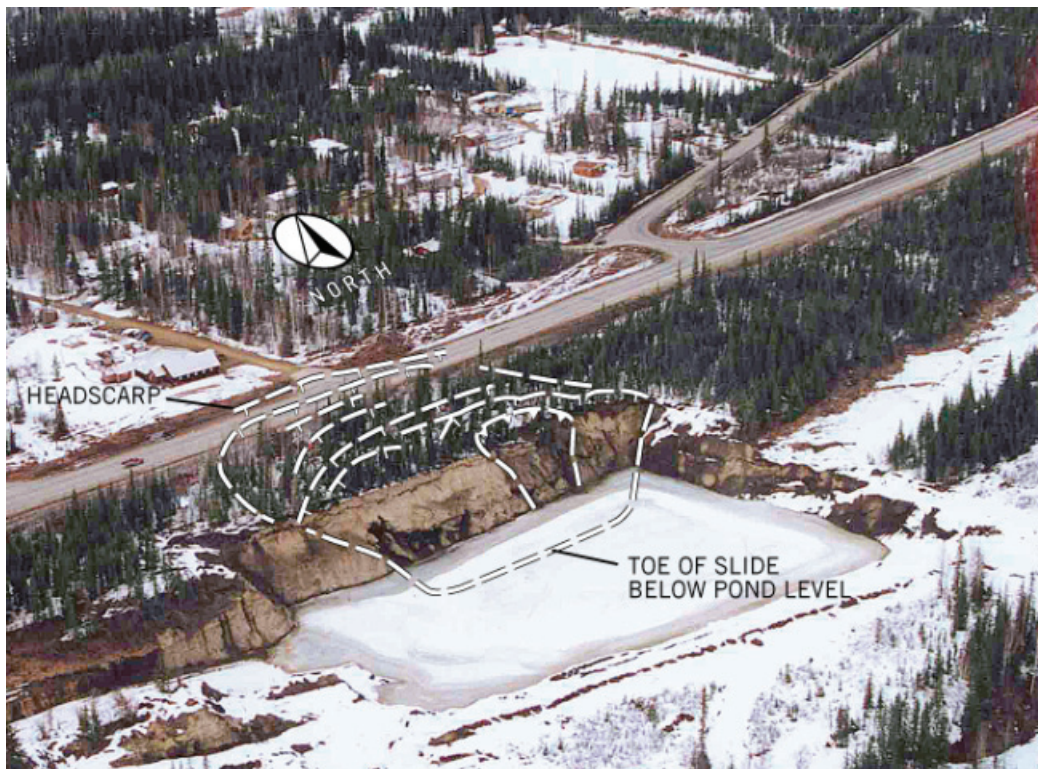
In the 1920's, dredging operations related to gold mining required the cutting of a channel through frozen silts. This channel, along with man-made fills and dredge tailings left behind by mining operations, is still evident. In the summer of 1999, a mining company excavated a 30 m deep pit across the dredge channel south of the Parks Highway. The subsurface soils exposed in the mining pit consist of frozen silts with zones of organics and ice inclusions (wedges and lenses). The silt unit ranges in thickness 24 to 30 m and is underlain by a layer of free-draining gold-bearing gravel, and in turn, schist bedrock. The upper 6 m of the silt is thawed and affected by seasonal freezing, whereas the silt below is perennially frozen. The gravel layer is predominantly unfrozen but contains discontinuous frozen zones. At about 30 m deep, the pit excavation encountered artesian groundwater flowing from the gravel. The mining company pumped the water out of the pit to allow excavation and mining operations to continue during September and October, 1999. Dewatering in the pit caused a drawdown of the groundwater table, particularly in the deep gravel layer, which impacted nearby residential wells (Alaska Department of Natural Resources (2000a). By October 1999, cracks were observed in the area between the edge of the open pit and highway, affecting the travel lanes. The mining company subsequently suspended pumping due to the indirect impacts and the pit began to fill with water. Initial cracking developed into fissures, up to 3.6m wide, over a period of 6 months. Figure 1

shows significant failures of portions of the northern pit wall, and slumping and development of scarps typical of a progressive landslide failure in the ground between the pit and the roadway. The eastern pit wall also experienced slump failures as the exposed ice-rich silt thawed.

**Figure 1.** Annotated photograph showing landslide conditions

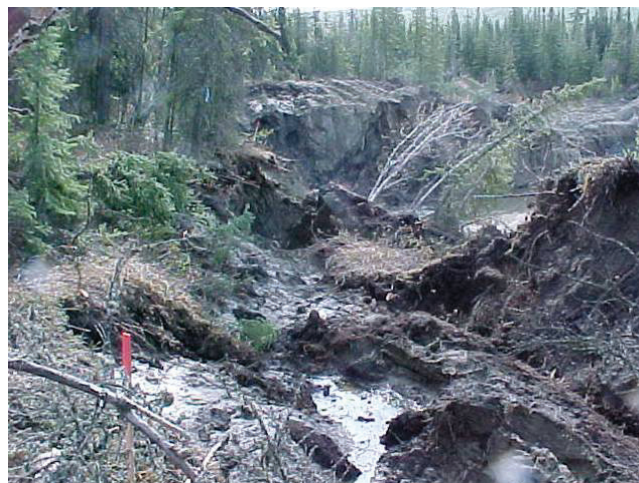
The landslide footprint is about 150 m wide by 80 m long with the toe exiting into the bottom of the mining pit to the south of the highway. In May 2000, the tension cracks and the distress to the pavement had progressed to the point that a full-width asphalt-concrete overlay patch was required to repair the travel lane. A graben appears to have formed in the south embankment slope. Figure 2 shows representative scarps and slumps.

**Figure 2.** Landslide Scarps and Slumps

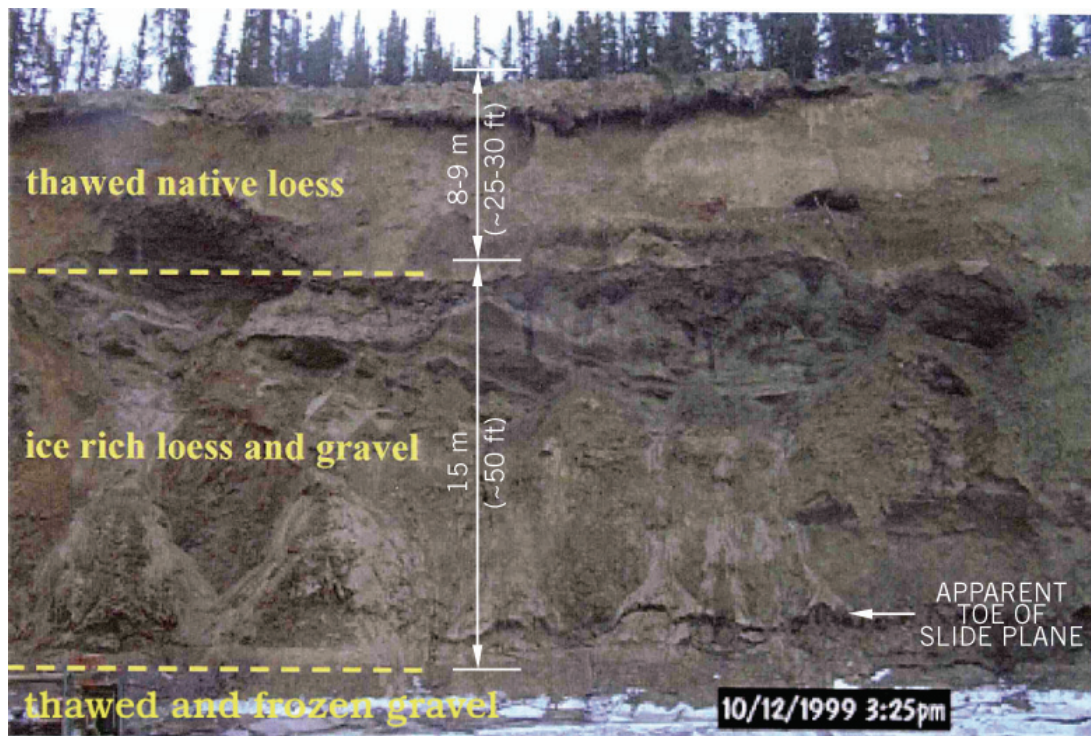
**Figure 3.** Stratigraphy in mining pit wall (Alaska Department of Natural Resources)

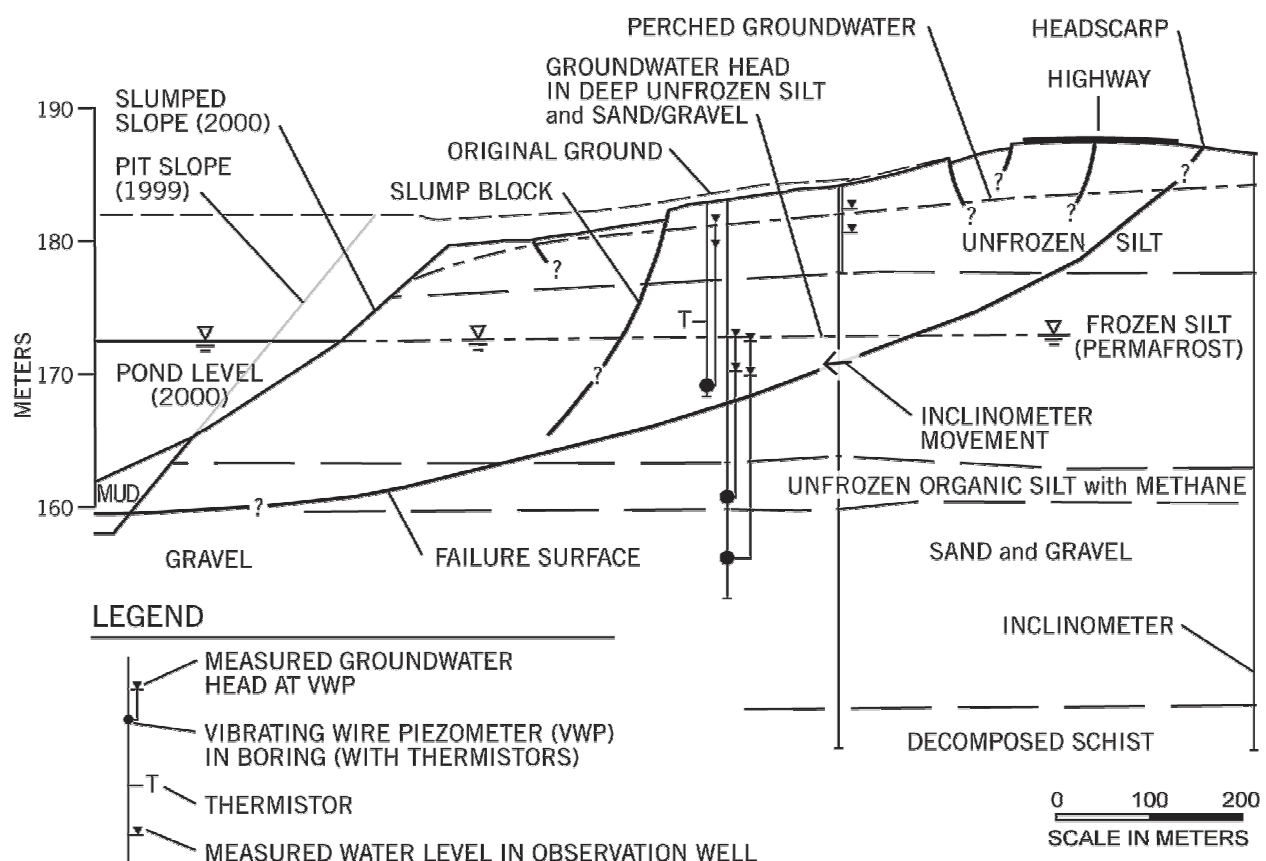
Seven borings were completed in two phases of explorations to investigate the conditions related to the landslide. The drilling encountered moist to wet loessal silts to a depth of about 6 to 7.6 m, underlain by frozen silt to at least 21.3 to 24.4 m, as shown on the cross section in Figure 4. The permafrost silt contained ice lenses and interstitial ice. It was not possible to detect shear zones in the samples recovered. There are confirmed water-bearing zones. Methane gas was encountered in organic silts at about 16 m deep in two borings. Below the permafrost silt, the material graded to a combination of quartz and schist gravel. Occasional layers of silt were encountered in the gravel unit. The gravel is underlain by weathered schist bedrock.

**Figure 4.** Interpreted landslide cross section

The two inclinometers in the active slide detected landslide displacement along the failure plane. Figure 4 shows the depth of measured shear displacement at a depth of 14.3 m (47 ft), recording an average rate of 1.7 mm/day over 2 months. The inclinometers installed on the north side of the highway (upslope of the headscarp) did not detect landslide-related movements.

The depth of the slide varies from head to toe (refer Figure 4). The landslide was caused by the mining excavation, which effectively removed toe support. At the mine pit wall, the basal landslide shear zone appears to be below the water level in the pit, near the contact of the permafrost silt over the gravel unit. The upper thawed silt also appeared to be sliding locally along the contact with the underlying permafrost. Ground movements determined by survey monitoring were greatest towards the mining pit. The ground in the lower half of the slide moved about 1m in a 6 week period (21 mm/day average), while the edge of the highway experienced smaller rates of movement (about 2 mm/day). To the east and west of the landslide, the ground surface appeared relatively undisturbed (except for thawing) and no evidence of landsliding was observed.

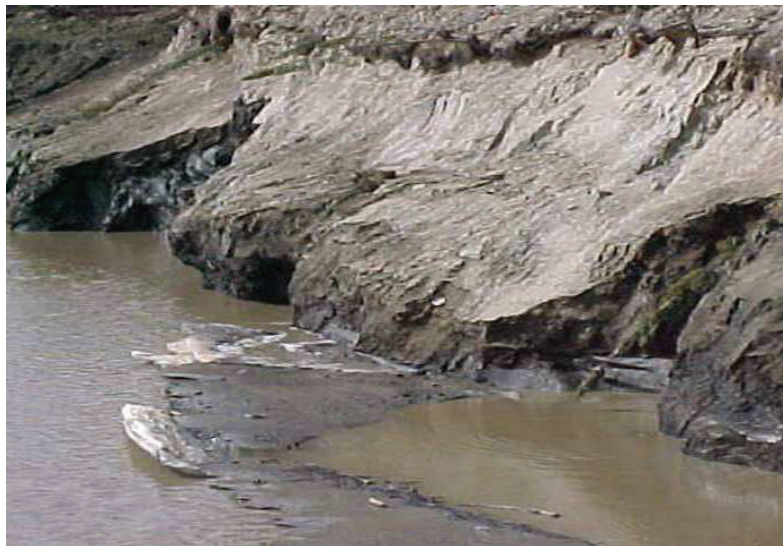
**Figure 4.** Landslide toe after cut slope ablated and pit filled with water

Since the pit walls were ablating and sloughing (see Figure 5), mud was forming in the bottom of the pond. A probing program was conducted to measure the thickness of the mud, which was performed during the winter while the pond surface was frozen. Holes were made in the ice to insert the probe. The probe consisted of a steel pipe with two different attachments

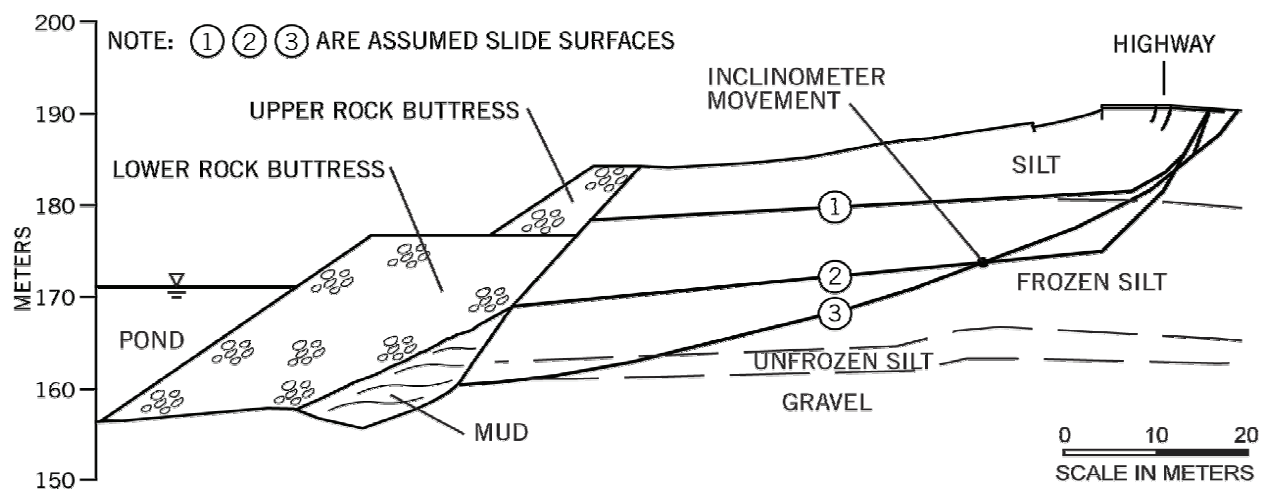
Preliminary stability analyses were performed to evaluate probable failure mechanisms. Slope stability computations were performed for a range of possible slide shear zone orientations (labelled shear zone cases 1-3 on Figure 6). The three potential shear zone cases that were selected for analysis included: 1) a shallow zone that would move along the contact of the thawed silt and the underlying permafrost, 2) a shear zone that passes through the measured movement depth in the inclinometer and exits midway in the pit wall, and 3) a deeper shear zone that passes through the measured movement depth in the inclinometer and exits near the bottom of the permafrost silt in the pit wall, near the contact with the underlying gravel unit. All three possible shear zone interpretations were analyzed to make sure that the mitigation measure to be designed would be effective for all plausible cases.

**Figure 6.** Stability analysis cross section

The first back-calculation for the residual shear strength of the ice-rich permafrost silt was for the slide initiation case, where an average undrained shear strength of 6300 to 8300 kg/m<sup>2</sup> was back-calculated (shear zone case 3). The results of the post-failure analyses (assuming landslide geometry during creep movement) resulted in back-calculated average undrained residual shear strengths for the three shear zone cases. The results are shown in the following Table 1, based on an assumed Factor of Safety, FS, of 0.99.

The landslide repair would consist of a combination of rock buttresses to satisfy all 3 potential shear zone cases. A smaller upper buttress built on top of a larger lower buttress is shown in Figure 6. The upper buttress would stabilize a possible shallow slide represented by shear zone case 1 and halt further sloughing of the exposed pit wall cut slope. The lower buttress would stabilize deeper shear zone cases 2 and 3. Stability analyses were performed on the selected conceptual buttress mitigation options. The width of the buttresses perpendicular to the roadway was sized to satisfy a factor of safety requirement of 1.3. This criterion (FS=1.3) was selected to

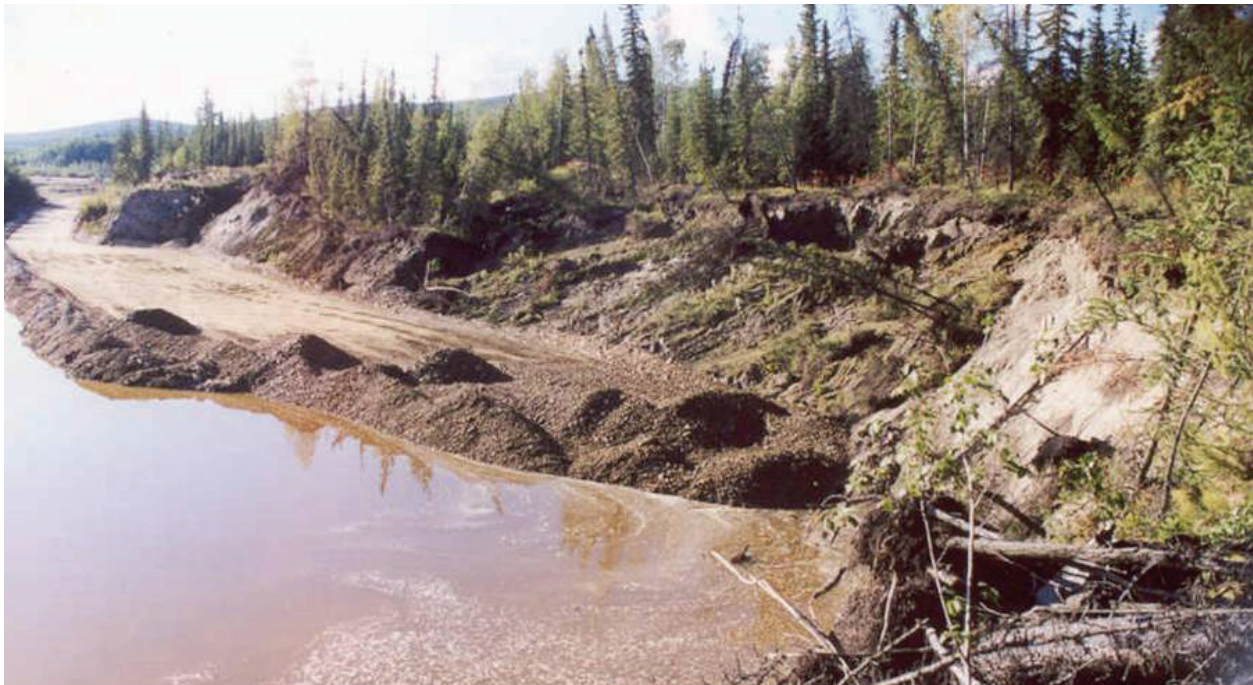
**Figure 7.** Staged construction of rock buttress, advancing across the mining pit pond

A filling approach was designed to slowly displace the mud, by placing the rockfill first against the face of the mining pit and then towards the pond, as shown on Figure 7. The advancing front edge of the rockfill was angled to achieve displacement of the mud. Using this approach, the slope of the rock buttress was able to be maintained at 1.5H:1V. Underwater soundings confirmed the angle of the steep rockfill slope that was achieved and also verified that the mudline beyond the rockfill toe had increased in elevation due to the formation of mudwaves from the displaced soft soil.

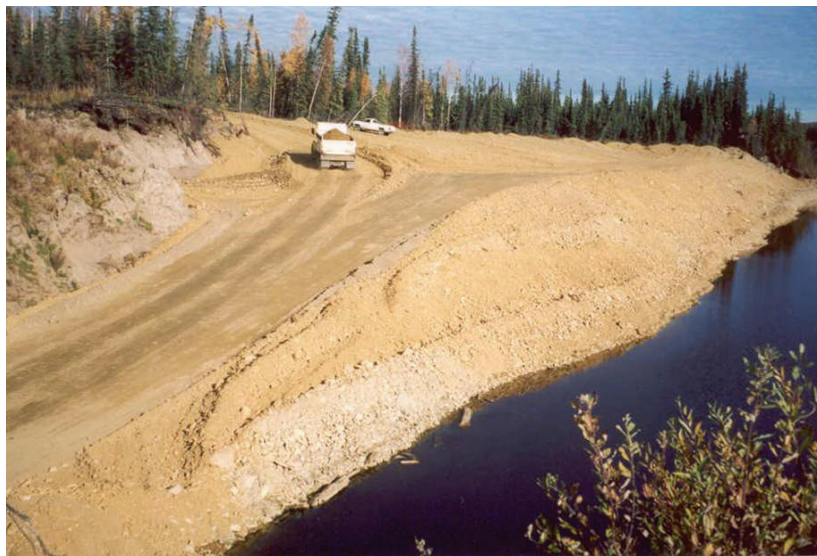
**Figure 8.** Raising the height of rockfill for the upper rock buttress

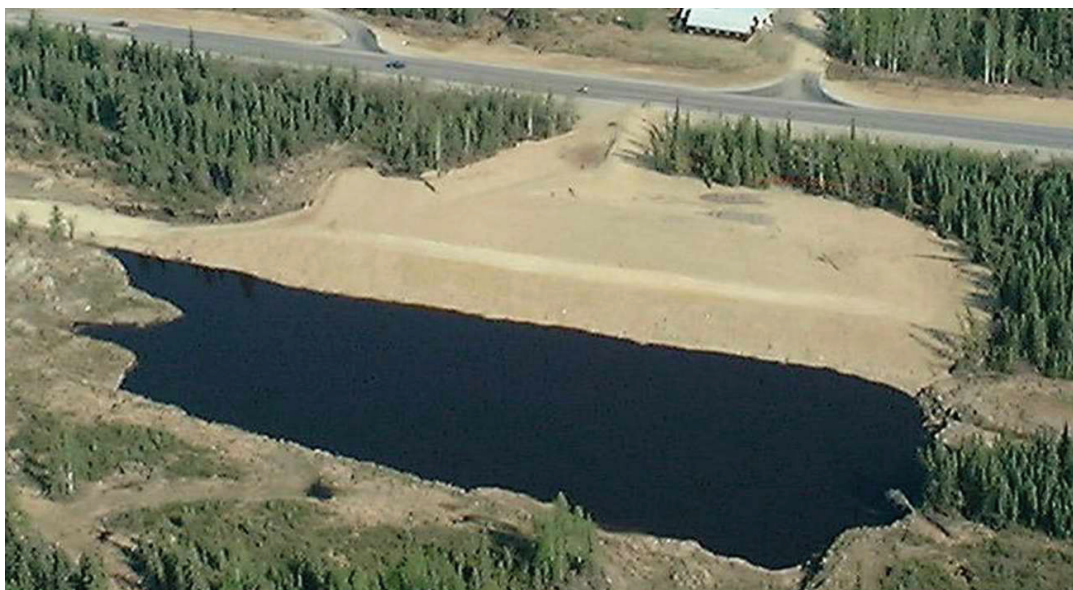
**Figure 9.** Completed rock buttresses

The placement of the rockfill into the mining pit pond caused an equal volume of water to displace and therefore the pond level rose. The rise in pond level was anticipated, and it was determined that eventually excess water would spill into the adjacent abandoned dredge channel. Utilizing the old dredge channel to convey displaced water helped control water quality because the channel was vegetated and provided a filter. The fill placement was conducted at a relatively slow rate, and monitoring verified it was not causing excessive turbidity. Downstream water quality was also checked. The rock buttress was constructed successfully and landslide movements essentially stopped. Figures 8 and 9 show the completed rock buttresses. The highway pavement was subsequently repaired by removing the cracked surfacing, then reinforcing the subgrade and reconstructing the base course and asphalt-concrete wearing surface. Observations over the past five years confirm that there has been no reoccurrence of scarps or subsidence in the highway pavement.
