The Sustainability of Experience — Investing in the Human Factor

28th Annual USSD Conference
Portland, Oregon, April 28 - May 2, 2008

MARMOT DAM REMOVAL

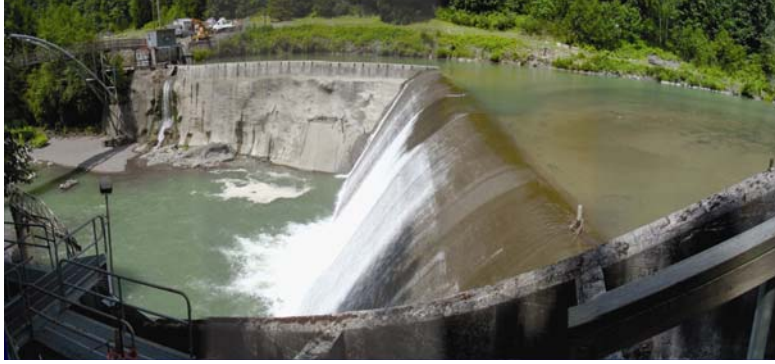
Figure 2. Photo of Marmot Dam

Located on the Sandy River (see Figure 1), Marmot Dam was a roller compacted concrete (RCC) structure with a conventional reinforced concrete overflow spillway crest length of 345 feet and elevation of approximately 733 feet mean sea level (msl). Figure 2 is a photo that shows the conditions that existed prior to the dam removal. As can be seen in the photo, impounded sediment had reached the top of the dam crest by the time it was removed. The concrete dam was constructed in 1989 at the site of a much older timber crib dam that was originally constructed in 1913. The main section of the dam was 195 feet long. A fish ladder on the south side of Marmot dam provided upstream passage. On the north end of the dam, a concrete gravity-section wing dam extended downstream to provide 140 feet of additional spillway, and to direct water to an intake structure. The intake structure had a trash rack and two tainter gates that regulated the diversion flow into a canal system. Figure 3 is an aerial photograph that shows these various features of the project. Marmot Dam was completely removed to the level of the original river bed. This included a section of the original timber crib dam that was buried in the impounded sediments just upstream of the structure. Appurtenant structures also removed included the diversion power canal inlet and headworks, and the fish ladder.

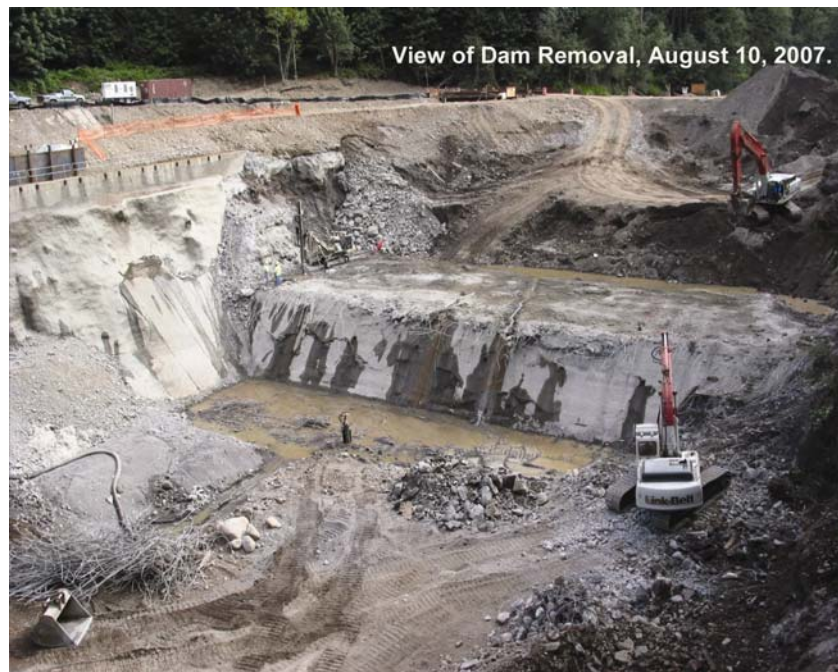
Figure 6. Dam Demolition in Progress

Marmot Dam was demolished using conventional controlled blasting techniques in four separate vertical lifts, with each lift averaging approximately 10 to 12 feet. See Figure 6 for a photo during blasting and excavation work. Sometimes there were more than one shot per each lift, but generally each lift was shot in one blast. Blasts for individual lifts ranged in total explosive weight from 4,500 pounds to over 10,500 pounds. Individual blast plan reports were required by the specifications.
