SEVEN DEADLY SINS OF LANDSLIDE INVESTIGATION, ANALYSIS, AND DESIGN

Derek H. Cornforth, former president, Cornforth Consultants, Inc., Portland, Oregon

Abstract: In practicing as a geotechnical consultant for more than 45 years, the author has observed that certain types of error recur in landslide studies and design. These errors, quite apart from their technical ramifications, frequently lead to costly lawsuits and sometimes fatalities.

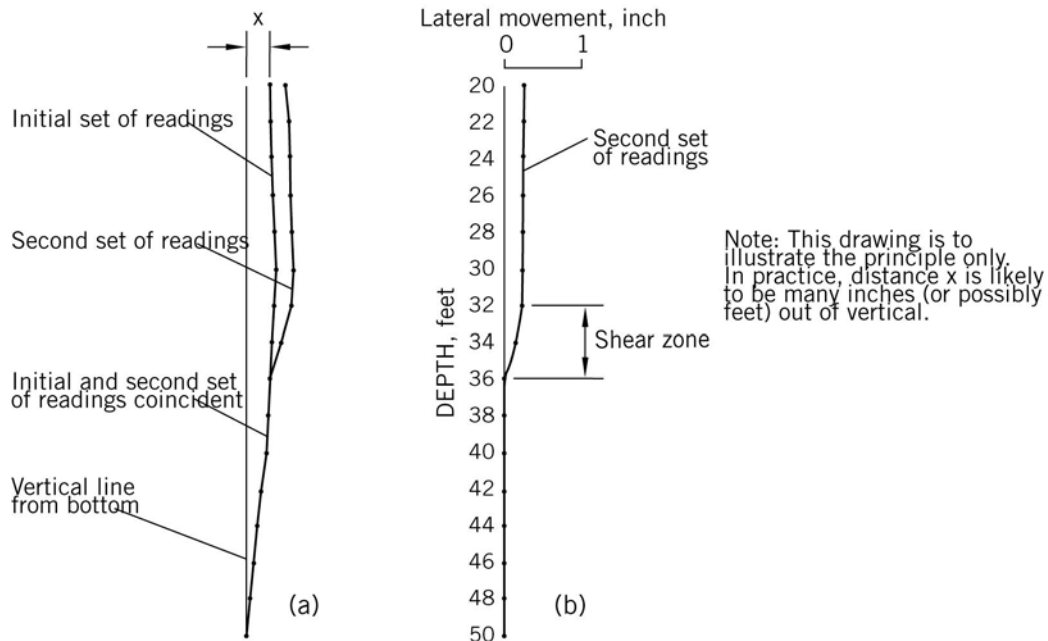
Figure 9. Examples of inclinometer data: (a) shape of casing in the ground for two sets of inclinometer readings (b) determination of shear movement and depth of shear during time interval between reading sets

deflection of the casing can be calculated by comparing a series of tilt readings taken at close intervals along the casing with an initial reading set to measure the change of tilt, if any, at each depth interval (Figure 9). When correctly installed and read, the inclinometer system can detect lateral movements of less than $\frac{1}{4}$ inch (6 mm). The equipment has been available for about 50 years and current versions (available from several manufacturers) provide a mature, reliable technology.

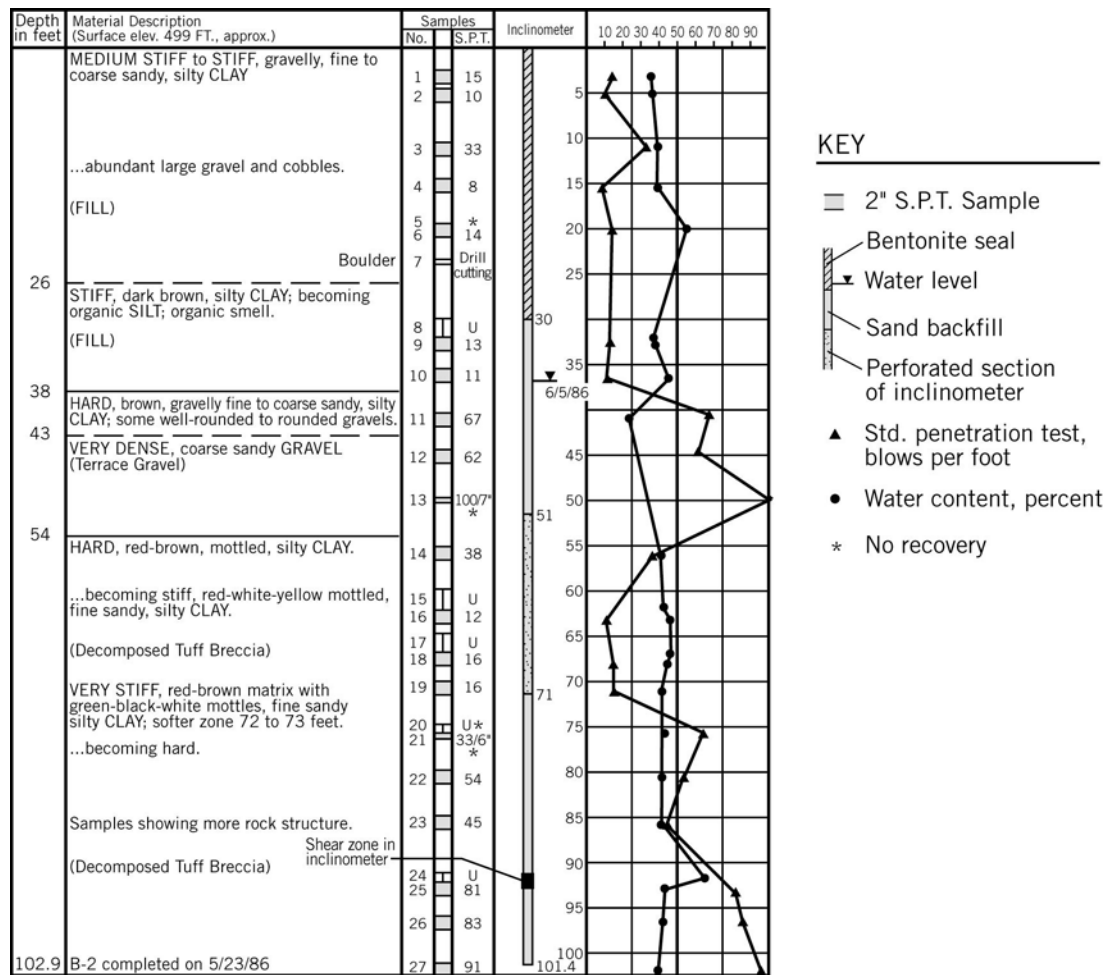
Figure 15. Faraday Canal landslide. Boring log for B-2.

The site investigation of 1986 included four borings through the center of the landslide to provide a geological section for stability analysis (Figure 14). The section shows a thick layer of clay fill overlying dense terrace gravel (old river channel) and hard silty clay (decomposed tuff breccia). A typical boring log from the site investigation is reproduced on Figure 15. There are exposures of the tuff breccia in the river bank close to the site where it stands at a near-vertical slope and has a rock-like appearance.

Without the benefit of inclinometer data, where would an experienced geotechnical practitioner expect the slip surface to be located? The probable choice would be at the base of the clay fill at the fill/dense gravel contact. This would be significantly in error. If using the boring logs as a guide, a second choice might be the “softer zone” at 72-73 feet (approx. 22 m) in Figure 15, for example. However, the actual depth of slippage at this location is 20 feet (6 m) deeper. Therefore, both choices would be wrong.

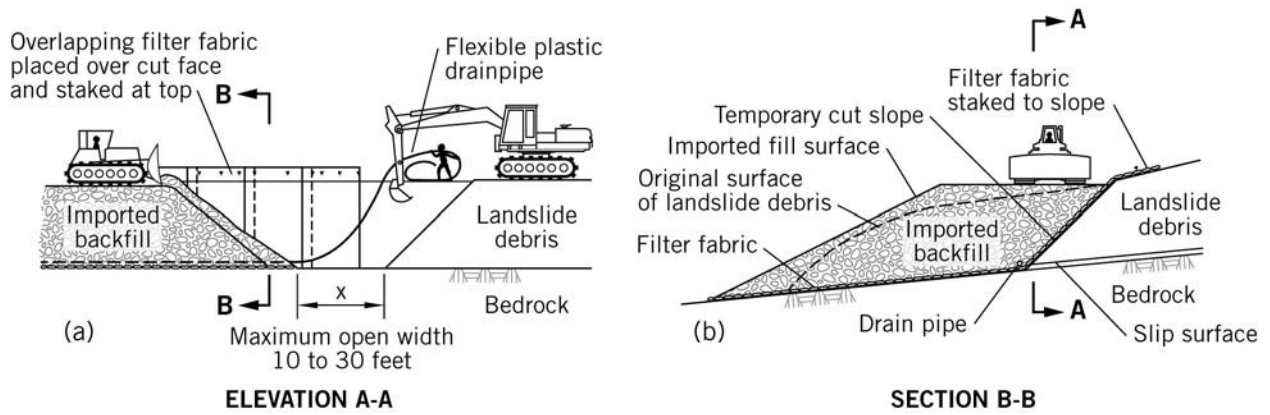
Figure 20. The closely-sequenced construction method

The closely-sequenced construction technique is illustrated on Figure 20 and requires that excavation and backfilling occur together such that the length of open excavation is kept to a practical minimum at all times. When site work is suspended overnight or at weekends and holidays, the excavation is temporarily backfilled with loose excavated soils. These soils are quickly re-excavated at the start of the next shift. The need to totally backfill the open excavation overnight is discretionary, depending on site conditions, public safety, etc. On many sites, backfilling to zero base width (i.e. distance $x=0$ on Figure 20) is sufficient.

Two stages of excavation were needed at the Lorane Road site. The first stage was to excavate the upper part of the slope, above the water table, by customary open excavation methods. For the second stage, a closely-sequenced construction procedure was followed, restricting the maximum width between the bases of the excavated soils and the rockfill (distance x , Figure 20) to 20 feet (6 m). A photograph of the work at Lorane Road is shown on Figure 21.

To build the lower section of the rockfill buttress, closely-sequenced construction was specified as mandatory.

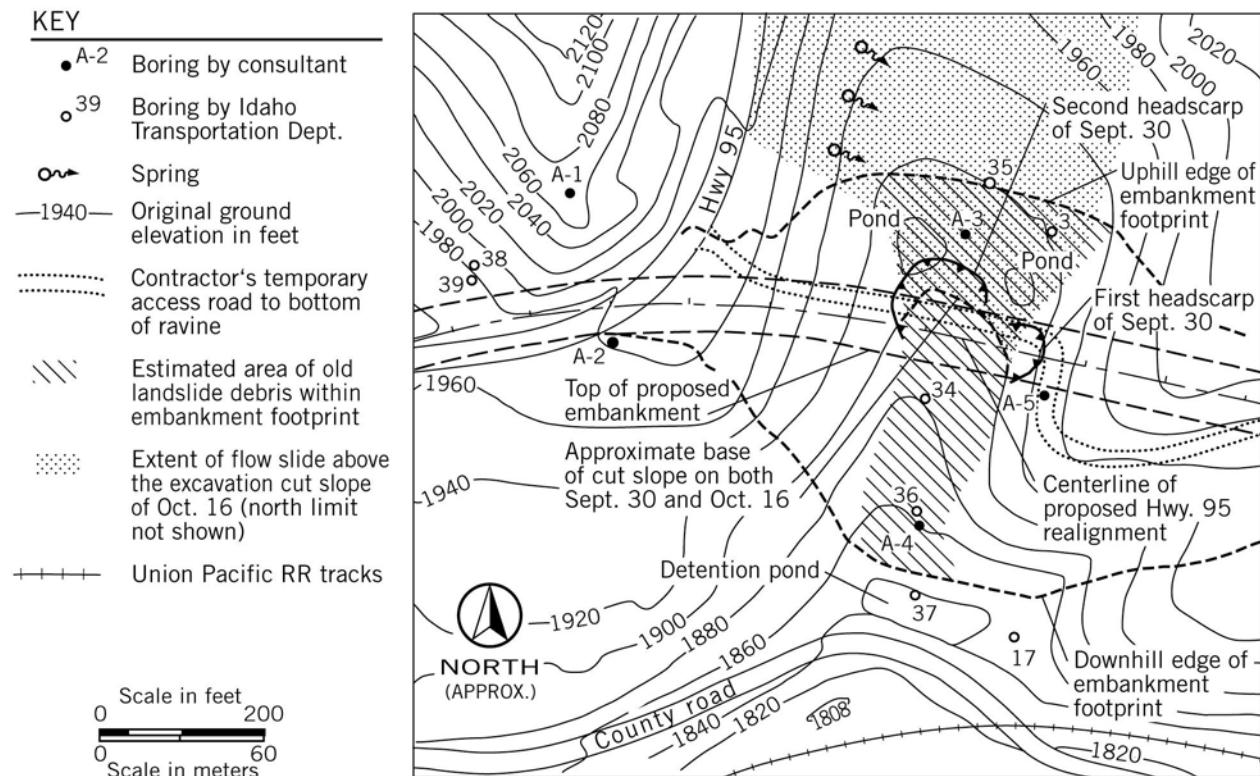
The site plan, Figure 23, shows the footprint of the proposed embankment. The contract required about 50,000 cu. yd. (38,000 cu. m) of the loose landslide materials to be excavated to provide a firm foundation for the embankment fill. This area is shown cross-hatched within the footprint.

The site investigation for the project encountered a flowing artesian condition in boring A-3 on the north (uphill) side of the excavation area (Figure 23). The boring log, simplified from the original, is shown on Figure 24. The artesian head, at a depth of 31 feet (9.5m) in the boring, was 9.6 feet (2.9m) above the ground surface in January, 1997.

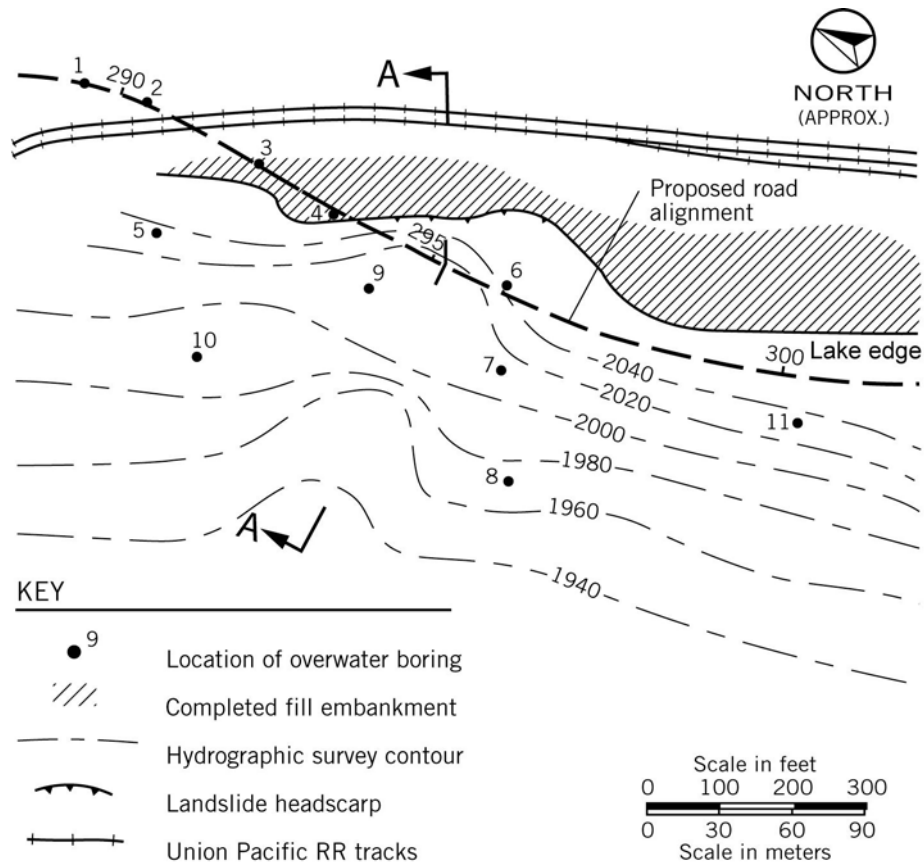
Figure 27. Lake Pend Oreille landslide: Site plan

The only site investigations in this area prior to the work suspension were on-land borings (1, 2, 3, 4, Figure 27) that encountered terrace gravels overlying bedrock. After the failure, seven over-water borings were put down (5 to 11, Figure 27). They encountered soft, silty clay underlain by argillite bedrock.

A hydrographic survey of the failure area (Figure 27) showed that a deep trough had been scoured out below the lake by the landslide. A cross-section taken through the center of the trough (Figure 28) showed a mound below water with the top at depths of 50 to 60 feet (15 to 18 m) below the lake surface. The steep outer slope of the mound (maximum 45 degrees to the horizontal), is interpreted to be angular rockfill that slid to this position. The clay that was formerly at this location apparently had been eroded and flowed into a deeper part of the lake. Unfortunately, none of the over-water borings were within the trough. However, the borings on both sides of it provide a means (by interpolation) to draw approximate contours of the ground surface, bedrock surface, and the depth of clay sediments. These contours (not reproduced here) show that the clay progressively thickens from 0 at the shoreline to 60 feet (18 m) in boring 10.

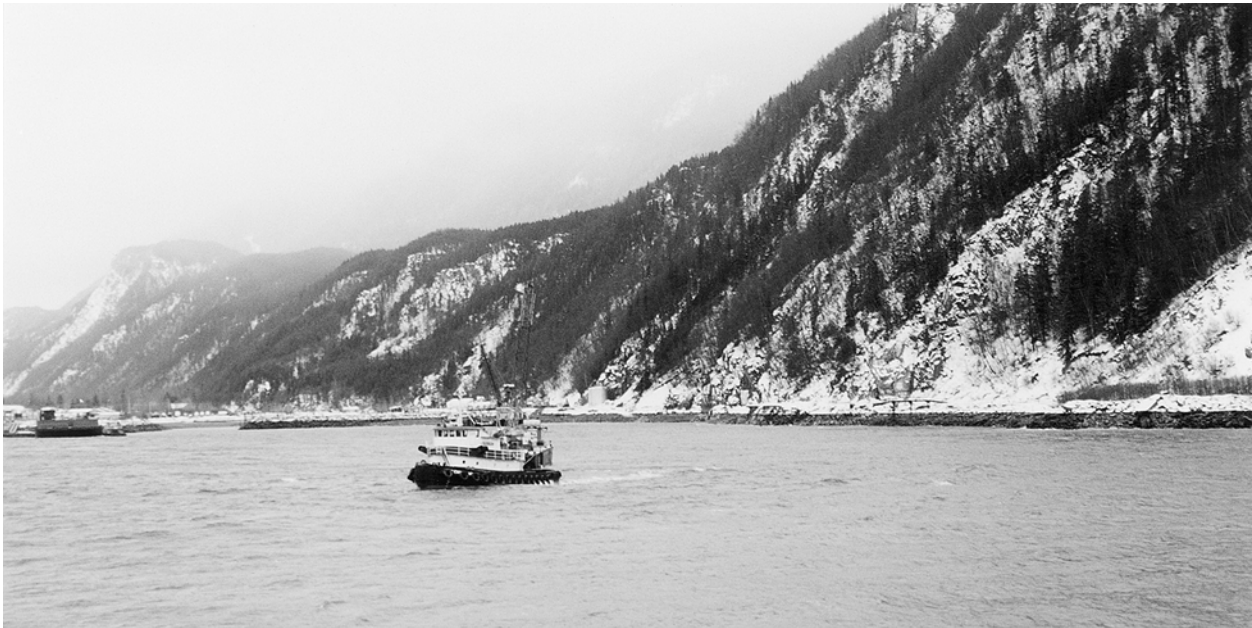
Figure 30. Steep rock walls on the east side of Skagway harbor.

The east side of Skagway harbor has a very steep slope of hard rock that plunges into the fjord of Taiya Inlet (Figures 30, 31). Below water, a slope of soft marine silt has been deposited between the steep rock slope and the delta of the Skagway River.

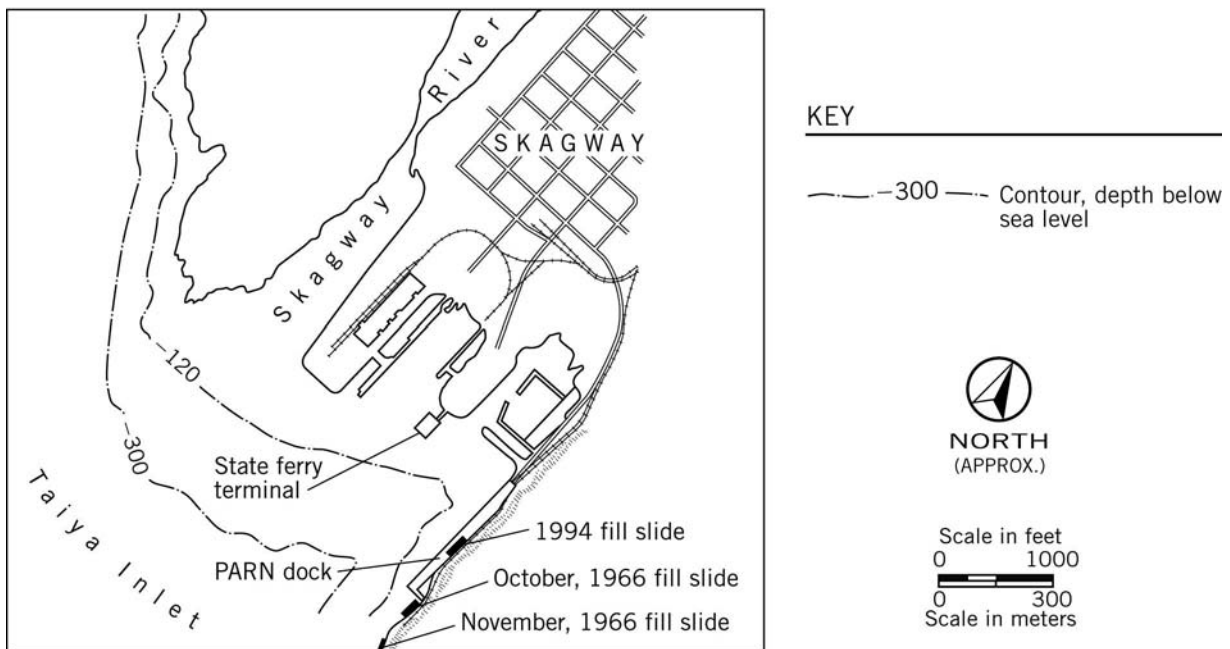
Figure 31. Skagway harbor and landslide sites

The “site investigation” consisted of driving seven wooden piles into the ground from a floating barge. Four of the seven piles sank 10 to 15 feet (3 to 4.5 m) under the weight of the pile-driving hammer, indicating very soft underwater conditions. An old timber wharf was demolished and fill was placed into the bay on 12-hour shifts. Four weeks later on October 29, 1966, when the work was nearly completed, most of the fill collapsed and disappeared below water overnight.

Following the October 29, 1966 landslide, the project developers tried to build another fill. On November 8, 1966 the original contract was amended to build a fill into the harbor 400 feet (120 m) further south (see Figure 31 harbor plan). The contractor began filling immediately, but the project was stopped on November 30 because a 300-foot (90 m) long crack with a 2-inch (50 mm) vertical displacement had appeared on the fill surface parallel to the shoreline. The site was abandoned.
