VINGTIEME CONGRES
DES GRANDS BARRAGES
Beijing, 2000

**AN INTEGRATED STRATEGY FOR SEEPAGE CONTROL FROM BULL RUN
DAM # 2 SPILLWAY APPROACH CANAL (*)**

Azad MOHAMMADI, Ph.D., P.E.
City of Portland Bureau of Water Works

Andy VESSELY, P.E., C.E.G.
Cornforth Consultants, Inc.

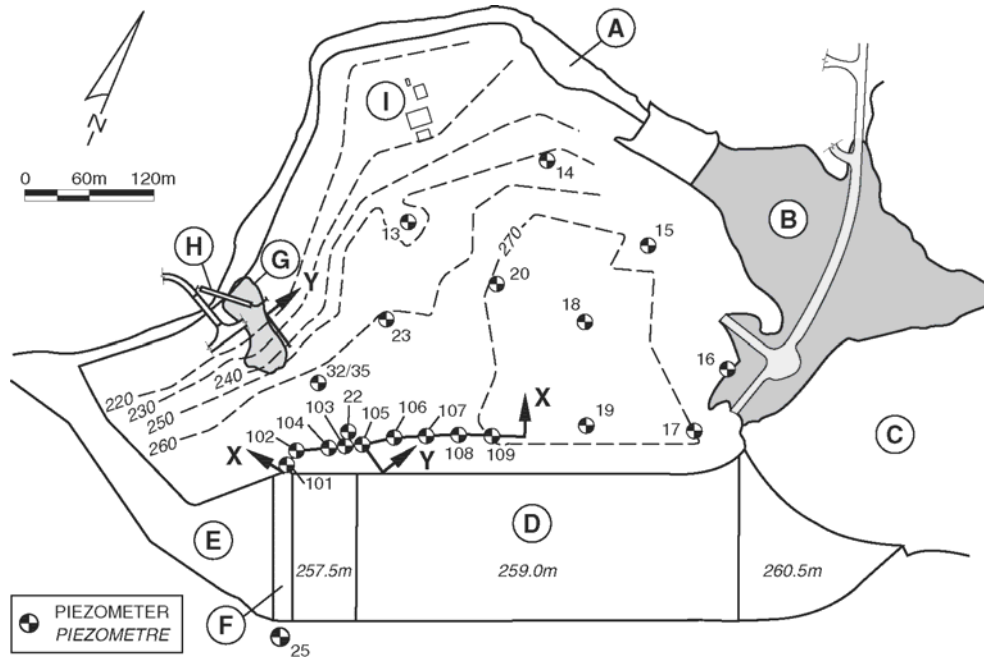
Fig. 1

Site Plan

Of the 25 original piezometers, 12 are located in the central area or near the spillway. These piezometers are P-13, P-14, P-15, P-16, P-17, P-18, P-19, P-20, P-22, P-23, P-25, and P-32/35 (Fig. 1). Additional piezometers were installed in the 1990s to provide more information on groundwater levels north of the spillway. These recent piezometers are P-46 through P-52, and P-101 through P-109. Piezometers P-101 to P-109 were installed in 1998-99. Due to the short historical time span, these piezometers were not included in our review of historical piezometer data.
